October 2018

Water *Watch*

Withdrawn Red Alert
Threat Remains

Centre for Urban Water Resource (CURE)
Water Knowledge Centre
DHAN Vayalagam (Tank) Foundation

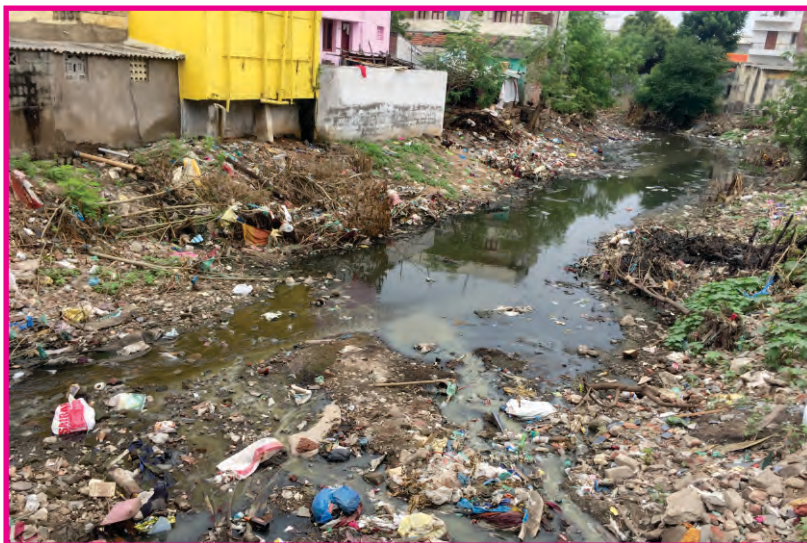
Water cleanses everything in its course, is no more 'true'. This is 'Sellur tank' surplus course. This channel which is flowing to a length of about 2.6 kilometers drains surplus of Sellur tank cascade into river Vaigai. The channel supposed to carry storm water and tank surplus water is carrying plastics, tailoring wastes, bottles, building debris, wooden debris and domestic wastes. People residing along the channel are loading the channel with biological and microbial contaminants by disposing their sewage and cattle shed washes. People believed that flood will wash away everything that was dumped in the channel. But the water left the stains in the channel, behind. Channels are 'arteries' of watershed and tank cascade system. When 'arteries' start to carry contaminates as 'veins' its death; the collapse of ecosystem; the fall of a city.

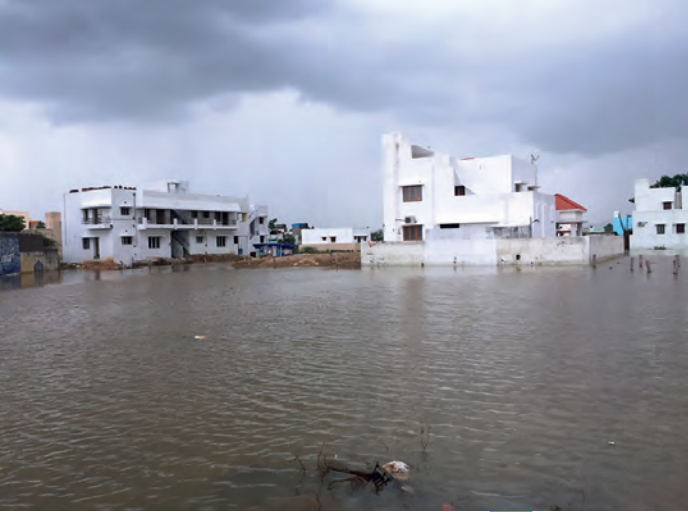
Bama Nagar

Inundation Description: About 40 acres of the command area was under inundation for two days. The depth of inundation was 1-2 ft. Though water did not enter the living area of the houses, it affected routine of the people. All the street roads were under submergence. School kids were not able to go to school and people were troubled while crossing the inundation for accessing the service road.

1. There was no surplus weir in the Mela Panangadi tank. This resulted in uncontrolled release of water through the surplus course. The surplus weir once existed much before was demolished by encroachers. The encroachers who encroached the water spread area of the tank have demolished the surplus weir to avoid submergence of their paddy field during Full Tank Level (FTL).
2. Reduced cross sectional area along the surplus course enhanced the velocity of the uncontrolled flow from the tank. The increased velocity exerted higher pressure on the surplus course bund and breached
3. The surplus course was encroached by weed. It reduces the surplus flow through the channel.

1. The tank water spread area must be marked as per Field Measurement Book (FMB) sketch and agricultural encroachment should be evicted. Survey stones should be placed along the tank fore-shore to restrict future trespassers.
2. 'Surplus weir' should be constructed for the Mela Panangadi tank. The surplus course should be designed and modified as per design discharge of the 'surplus weir'.
3. Currently the surplus course was deepened, widened and strengthened only for 200 m. The department should intervene in the remaining 750 m stretch along the downstream to avoid inundation in future.
4. 'A tank association' must be formed in which farmers and residents in tank command area should be members. This association should take care of maintenance of the tank.

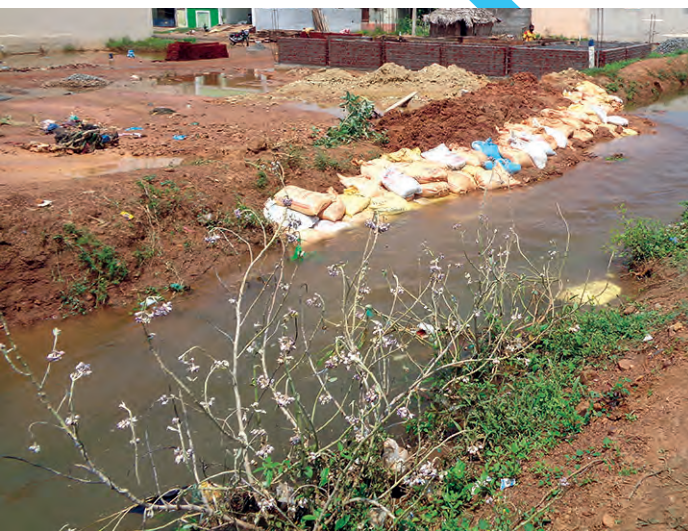
Mahalakshmi Nagar

Description: About 10 acres of the land in south of surplus course was inundated by flood water. Street roads and houses were inundated for more than a foot. As the tank was fed by sewage, 'high organic' green-sewage water entered households and streets. The communities suffered with foul smell for more than a day.

1. The tank was already filled to its Full Tank Level with sewage. This reduced the opportunity of the tank to hold storm water entering into the tank. This resulted in immediate flow of sewage mixed surplus water in its course.
2. The surplus course was encroached by residents along the channel. This reduced carrying capacity of the channel which resulted in inundation.
3. As the surplus course was covered by concrete blocks, the surplus course was choked by solid

wastes disposed into it. This blocked flow through the channel and back-flushing of water in the open spots.

4. Disposal of sewage into the storm water drainage added additional volume to the channel resulting in inundation.

1. The encroachments should be evicted appropriately. The encroachment evicted building debris was left unaddressed. This should be cleared.
2. As there is minimal flow in the channel, local communities has started to use the debris to cross over the surplus course. Therefore, proper culverts should be laid along the streets across surplus course to avoid future inundation.
3. Sewage should be restricted to flow into the tank and also into the storm water drainage. A proper sewage disposal mechanism should be implemented in the area.
4. The surplus channel should be cleared periodically to avoid chocks and proper solid waste management strategies should be developed.

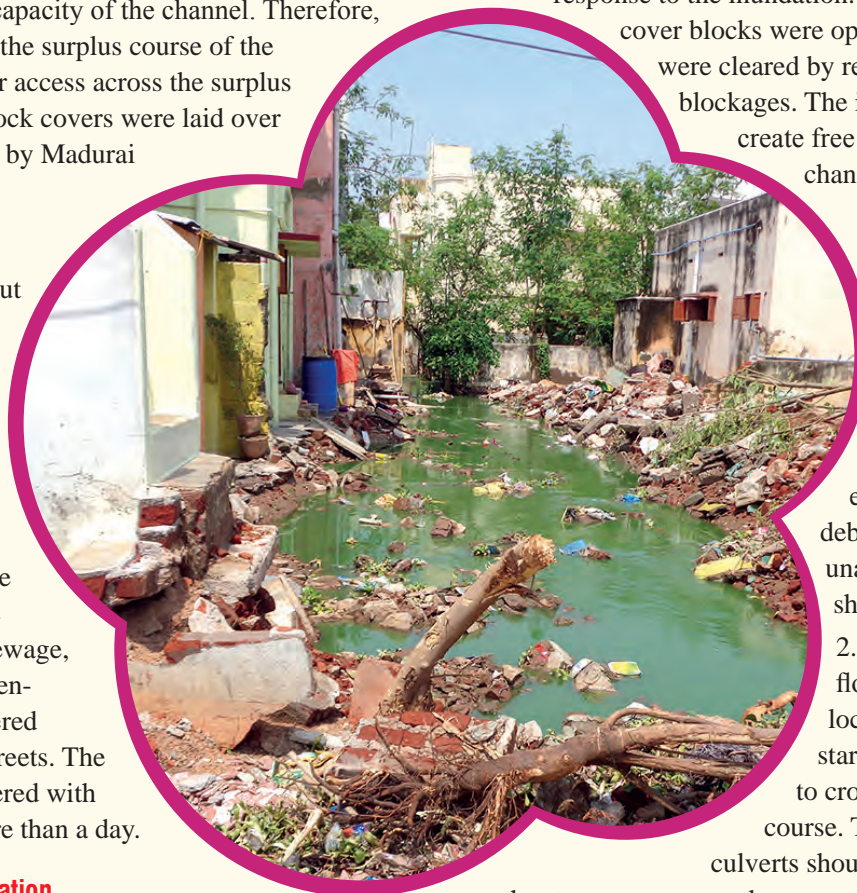
Inundation Description: About 90 acres of the land was inundated in TM Nagar. The depth of inundation varies from 1 – 3 feet. The inundation affected day to day life of the communities. An electric post fell and the supply was cut for safety purpose. There was unannounced power cut for more than a day. As bore water is the only source of drinking water, Unprepared TM Nagar residents suffered without drinking water. Packaged drinking water cans were brought by local residence with lot of struggle in passing the inundated roads. Bubbles coming out of paved roads indicated poor compaction while laying roads. The flood water inundated a house under construction. This inundation stalled the construction work for more than a week and spoiled all the construction material such as cement bags, steel bars, shuttering planks, sand, etc. Water resided only after 4 days of inundation. Old people residing in the locality suffered a lot for their needs. This was not the first such incident in this locality. Such incidents happen whenever there is heavy rainfall in Madurai. Most of the newly constructed houses were built above the flood water line, which is one of the adaptive mechanisms of local communities.

1. There is a sharp 90 degree turn in the Kodikulam surplus course. As sharp curve is the weakest point, to avoid breach the curve was strengthened by stone pitching in the left embankment. But the

stone pitching got deteriorated over the period. This deterioration resulted in breach in the left bank post the sharp curve. This breach was the main reason behind inundation.

2. There was another breach in the confluence point of Surplus courses from Kodikulam Tank and Parasurampatti tank. This was mainly because of poor water carrying capacity of both the channels.
3. There was one more breach in the southern part of TM Nagar, opposite to Meenakshi Mission Hospital. This was mainly due to back flow of Uthangudi surplus course caused by heavy flow in Parasurampatti surplus course.
4. Low carrying capacity of the surplus courses was mainly due to reduction in channel cross area. This was mainly due to siltation of channel, Prosopis and reed invasion in the channels and encroachment of the same.

1. The surplus course was deepened, widened and strengthened temporarily. This was not at all appropriate. One longer shower will wash away all the bund strengthening works.
2. As the sharp curve was frequently breached, proper bund strengthening should be established for better future. The bund strengthening or revetment process should be executed immediately.
3. Encroachment eviction and widening of channel is mandatory in all the surplus courses.
4. 'A Confederation tank association' must be formed in which residents in tank command area should be members. This association should take care of maintenance activities such as Prosopis Clearance and also performing tank cascade social auditing.
5. Future approvals for construction should keep the water levels in mind.

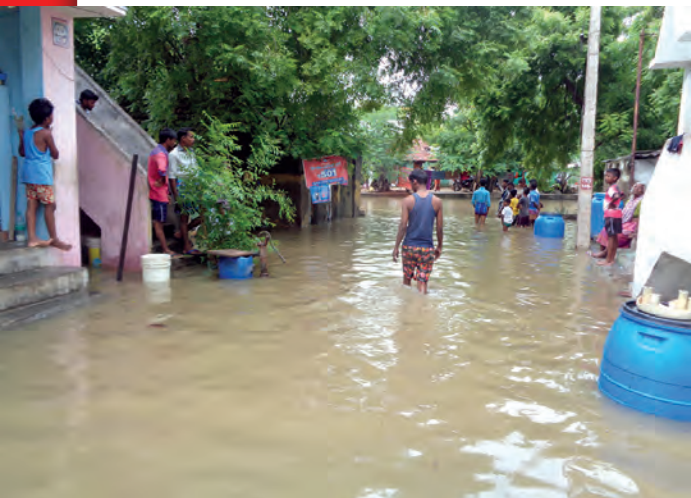
Avayar Street and Bose Street of Sellur

Inundation Description: About 6 acres of the area in the right bank of surplus course was under inundation for three days. The depth of inundation was 1-3 ft. Water flushed through streets and entered living area of the houses affected routine of the people. People in low lying area moved to their relative homes. Women involved in tailoring were affected severely. Water entered into living area wetted furniture, utensils and steel items in the home. Snakes, insects, worms were also predated along with the water. Women Self Help Groups supplied food packets for the affected communities. Some women cooked standing in the inundation itself. Kids did not go to school.

1. The surplus course was encroached by residents, cow sheds, shops, etc. This reduced the available cross sectional area of the channel.
2. The surplus course was heavily dumped with solid wastes such as household wastes, cow shed wash aways, wooden planks, fallen trees, tailoring wastes, etc. This reduced cross sectional area of the course. The flow in the channel rose above its High Flood level. This resulted in flow through open spaces in-between households and streets.
3. Storm water drains that supposed to drain water into surplus course are connected with the surplus course at its free board. As the course is flowing full, water started to back flow in the storm water drains. This further enhanced the inundations.

1. Encroachments in the surplus course should be evicted appropriately and debris should be disposed immediately.
2. Cross section of the surplus course should be verified for its design discharge and redesigned if any faulty design.
3. Thick sludge deposited as a layer in the bottom of the surplus course should be removed to increase cross sectional area of the course.
4. Solid wastes, fallen trees dumped in the channel should be completely cleared.
5. Proper solid waste and sewage management should be implemented to avoid future inundations.

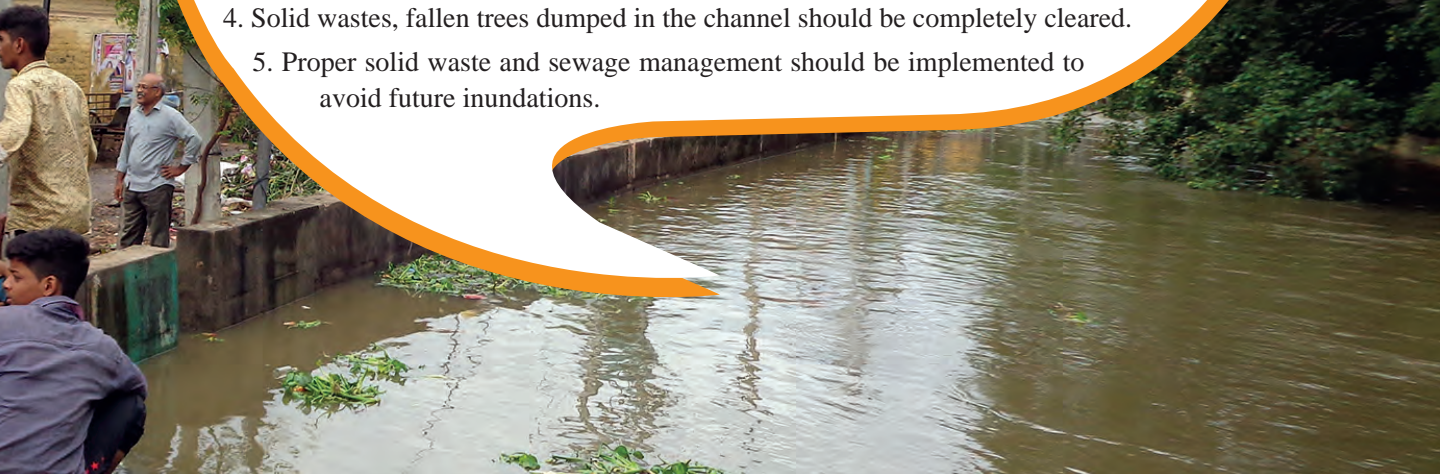
Mudakkathankulam tank

Surplus weir: It is absent (S.Alangulam, MelaPanangadi tanks) and leaky (Mudakkathankulam tank). These lead to uncontrolled discharge and reduced water holding capacity. Tanks should be demarcated as per FMB sketch and surplus weirs are to be restored as per design.

Bund strengthening: Pot holes (Siruvur tank) and rills (Mudakkathankulam tank) in the recently strengthened tank bund evidently prove that bund was not properly compacted during the rehabilitation process. In S.Alangulam tank, local communities avoided a breach in the tank bund by using sand bags. The bunds were not compacted using sheep foot rollers and as per standards.
