Water *Watch*

Quality Matters

Temple tank
A blue structure

Temple Tanks – Blue spots in Concrete Urban Fabrics!

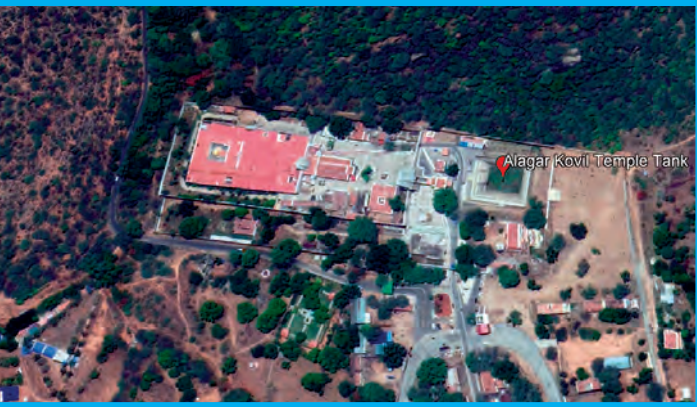
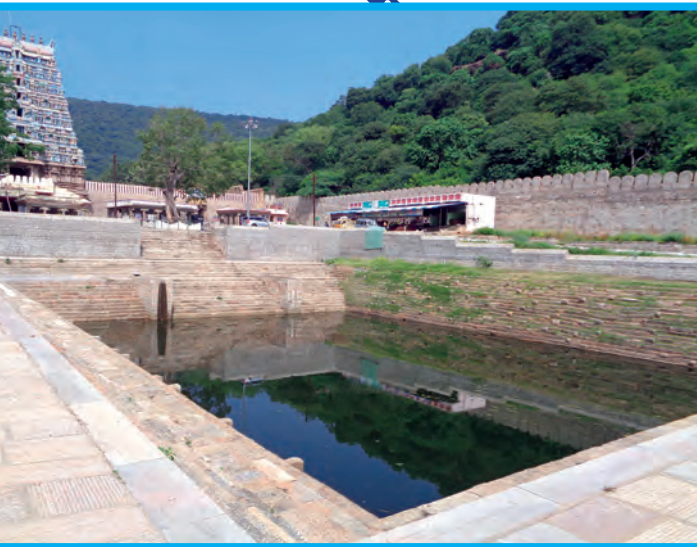
Azhagar Kovil Temple Tank

Structural Description: The tank is constructed with stone masonry side walls. The temple is having access in all directions. As the plants growing in-between the stone walls and steps are not removed in regular intervals, the bondage between wall stones and step stones are getting weaker. This is making the structure weaker and it may cause collapse of walls and steps if not addressed in time. As the Catchment Area for the tank is restricted to portion of the temple premises, water reaching the tank is minimal.

Description of Infection: The water in the tank is highly polluted because of disposing organic, inorganic and plastic materials as part of rituals. The water is green in colour. Samples revealed that the colour is due to Algal suspension. There is a common toilet in south of the temple tank. The faecal sludge management in this toilet is worst. Faeces are exposed to surface. During rainfall, the faecal sludge may get mixed with the storm water. This might pollute the temple tank to severe extent. Presence of reed in the tank shows the presence of silt depositions in the temple tank.

Functional Description: As the water in the tank is less than 10% of the total capacity and the quality of water is poor, access to water in temple tank is restricted. The water level in the tank does not reduce much even in the non rainy season. It shows that the tank is not contributing much to the ground water.

Recommendations: The tank should be desilted to improve ground water recharge from the tank. The toilet near the tank must be repaired for proper faecal sludge Management. The plants growing between joints of stones in wall and stairs must be removed and proper bonding between stones must be carried out. Catchment Area of the temple tank shall be increased by proper rain water harvesting design. Weed and plastic wastes floating or sedimented in the tank should be cleaned. Disposal of ritual materials should be regulated in a way that it will not contaminate the water.

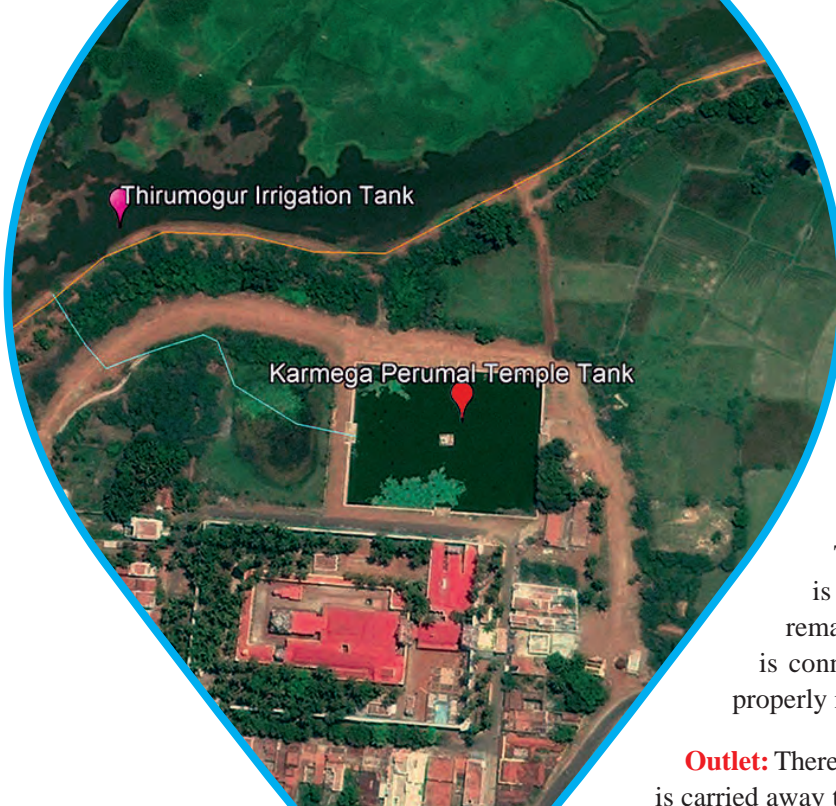
Karmega Perumal Temple Tank

Structural Description: The tank is constructed with stone masonry side walls. The temple is having access in all 4 directions via Ghats. The stone walls and steps are in good condition and well maintained.

Description of Infection: The tank water is slight yellowish (Like urine) in colour. The colour may be due to presence of dissolved solids present in the water which was contaminated by the detergents, soaps, ritual disposals and thermocol pieces.

Recommendations: Regular cleaning of floating solids disposed in the temple tank should be addressed in regular intervals.

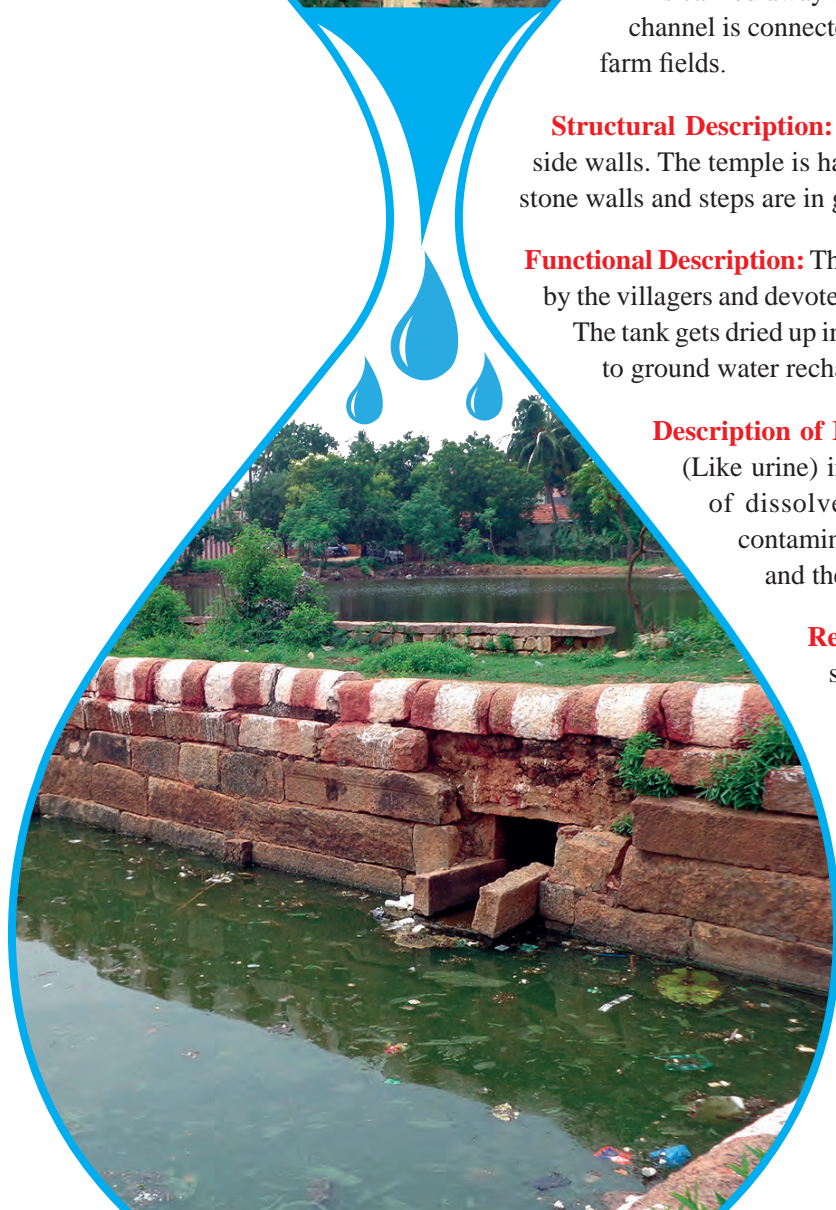
Marugaal Udaiya Ayyanar Temple Tank

Outlet: There is a provision for the outlet in the tank but the provision has been chocked and currently not functional

Structural Description: The tank is constructed with stone masonry side walls. The parapet walls are constructed by brick masonry and were plastered by cement mortar. The temple is having access in two opposite directions only via Ghats. The walls and steps are in good condition and well maintained. There is an open well inside the tank. A bore and pipe set up was established to pump water for domestic usage of communities. The tank is heavily silted.

Functional Description: As the water in the tank is less than 20% of the total capacity and the quality of water is poor, people are not accessing the water. Siltation of the tank reduces its ground water contribution.

Description of Infection: The open space around the temple tank is used as cow sheds. The area is highly polluted by cow dung and urine. The storm water used to carry all these wastes along with it before entering the temple tank. The water is 'slightly higher yellowish' than Thirumogur Temple Tank. The well is full of solid waste disposals.

Recommendations: The temple tank should be completely desilted and cleaned. A regulatory mechanism such as 'temple tank association' should be established to maintain the tank and restrict solid waste disposals. The catchment area of the tank should be prohibited for cow sheds. The catchment area of the temple tank should be increased by proper rain water harvesting design. Possibilities of feeding the temple tank from Uthangudi tank surplus shall be explored. The outlet channel is to be restored.

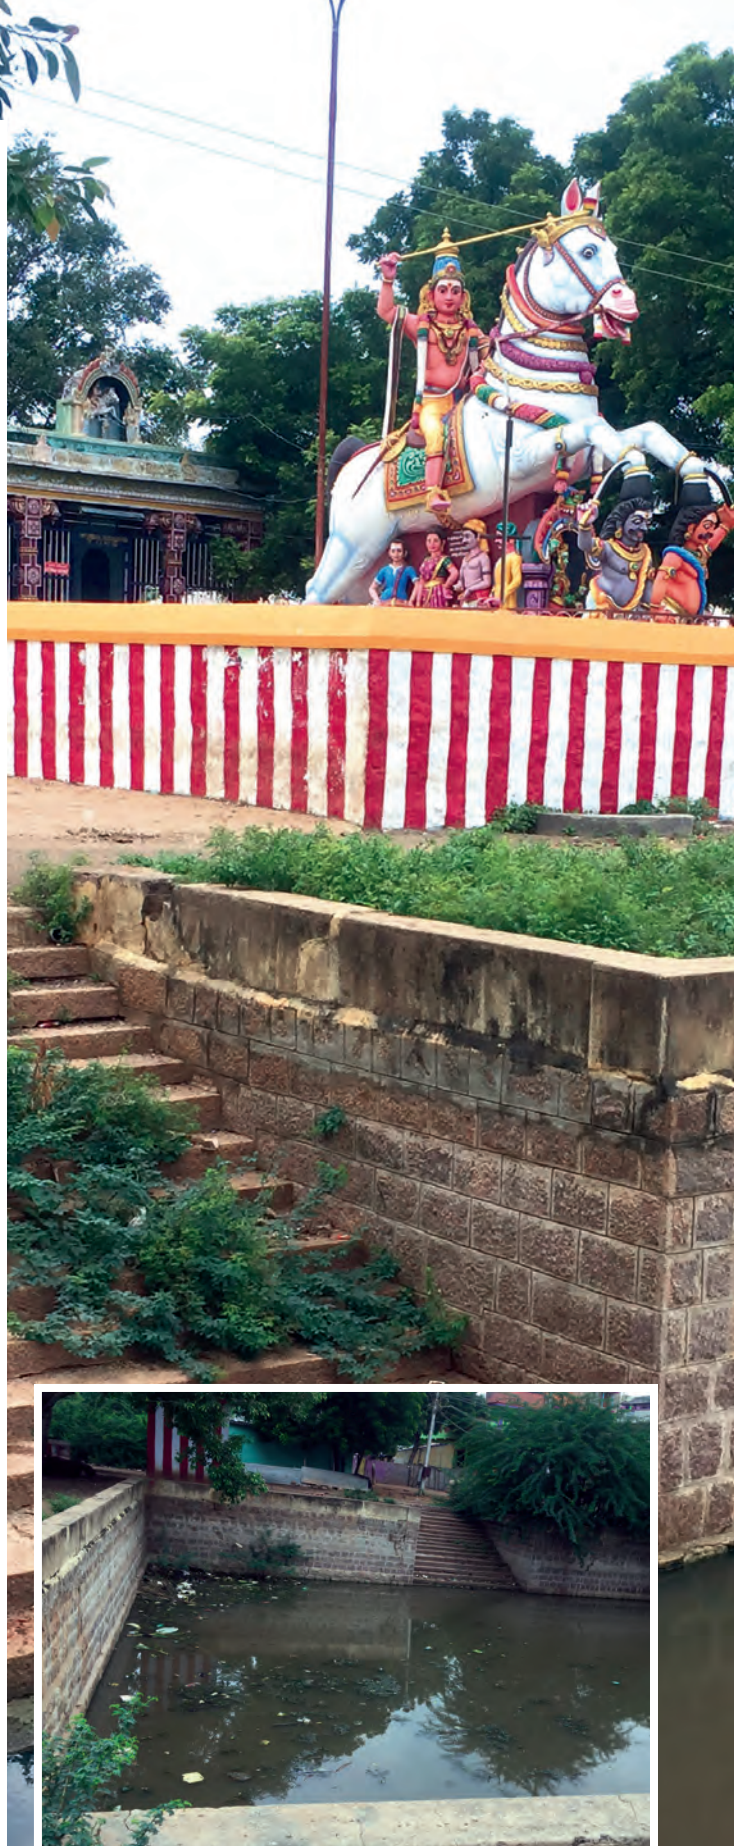
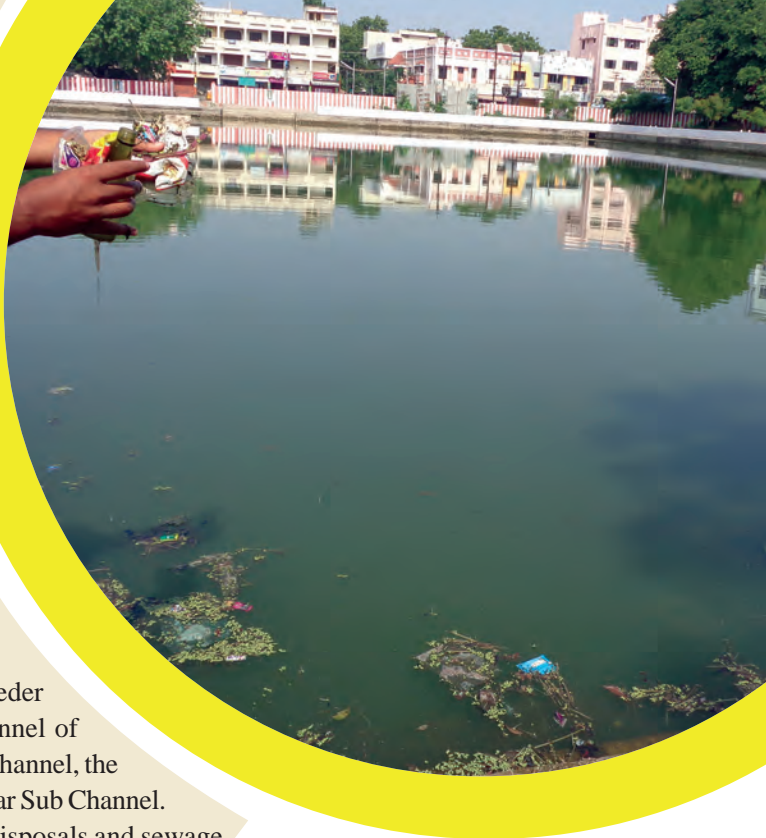
Prasanna Venkatachalapathy Temple Tank

Inlet: The Temple Tank receives water through a feeder channel that receives water from one of the sub channel of Periyar Main Canal. As sewage is disposed in this sub channel, the inlet gate remains closed until water is released in Periyar Sub Channel. The feeder channel is highly polluted by solid waste disposals and sewage.

Outlet: There is a provision for the outlet in the tank but the provision has been chocked and currently not functional. Remains shut.

Description of Infection: As the Periyar water flowing through feeder channel flushed and carried away solid waste disposals and sewage, the temple tank was polluted by it. The water looks green due to algal growth in the sewage mixed tank water.

Recommendations: The tank is to be regularly cleaned to remove floating and settleable solids which was flushed by feed water. The outlet channel is to be restored and the tank space is to be opened for public usage.

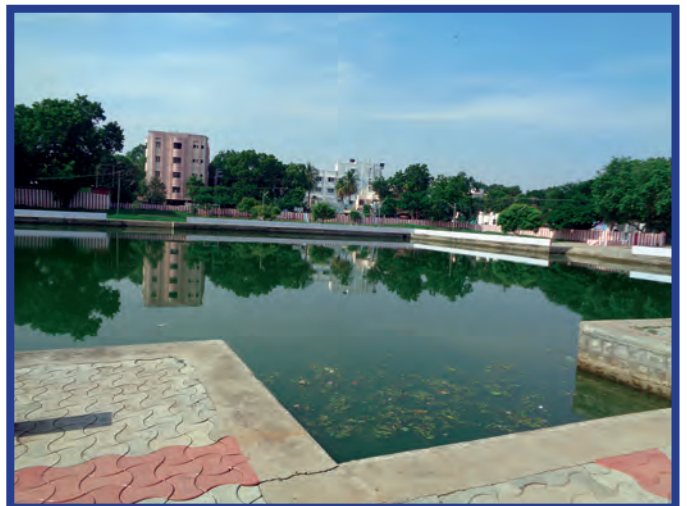
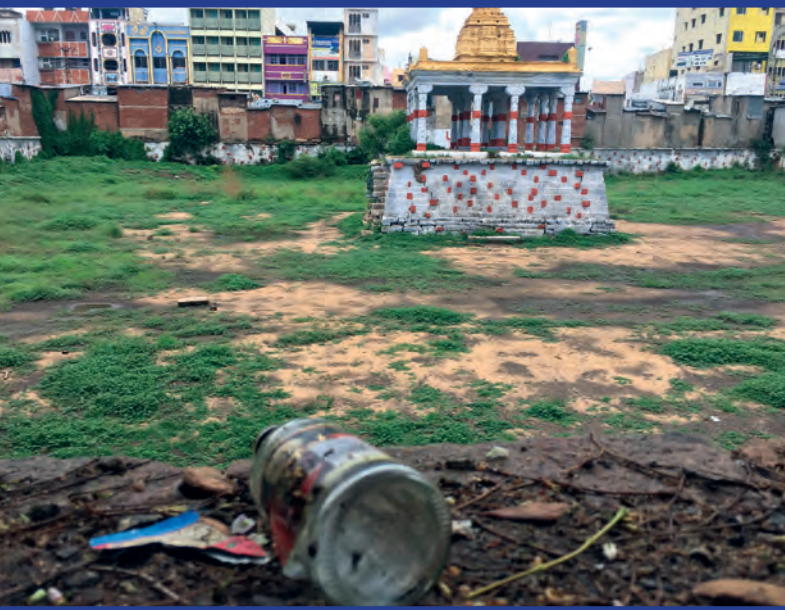
Koodal Azhagar Temple Tank

Inlet: The Temple Tank once received water from Vaigai river. As the connection was broken due to poor town planning, the tank was never full for past two decades.

Structural Description: The parapet wall, Ghats, open space of the tank around it was completely encroached by row of shops in all directions. Though encroachment was evicted partly in south direction, the demolished building debris was left unaddressed. The side walls and Ghats of the tanks are also damaged.

Description of Infection: People urinate in the southern Ghat where shops were partly evicted.

Functional Description: As there is no water and no way to access the water, it is dysfunctional.

Recommendations: As per the tank boundary, encroachments should be evicted completely and building debris should be disposed properly. The feeder channel is to be provided for drawing water from existing storm water drainage running parallel to the tank in north direction. Ghats, Parapet and side walls are to be restored. Local Catchment Area has to be increased by proper Rainwater harvesting design.

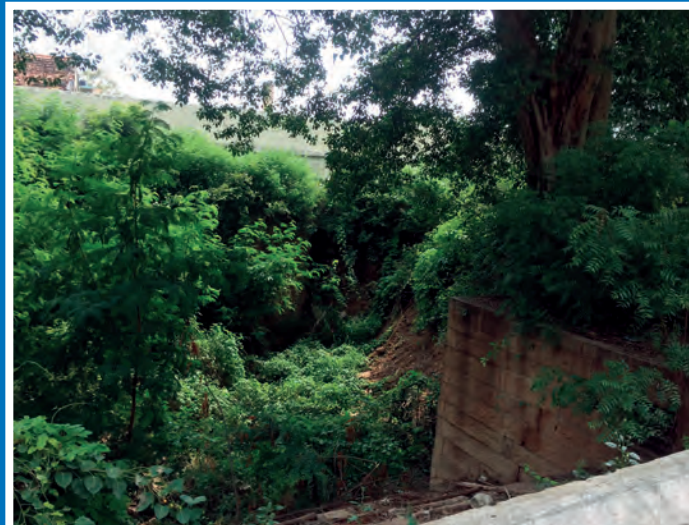
Saravana Poigai

Description of Infection: As the fishes in the tank were caught completely, it led to collapse of the tank ecosystem leading to poor 'greenish water' which smells bad and itches when taking bath. Number of people using it has reduced drastically.

Recommendations: The ecosystem of the tank has to be restored efficiently with proper solid waste management.

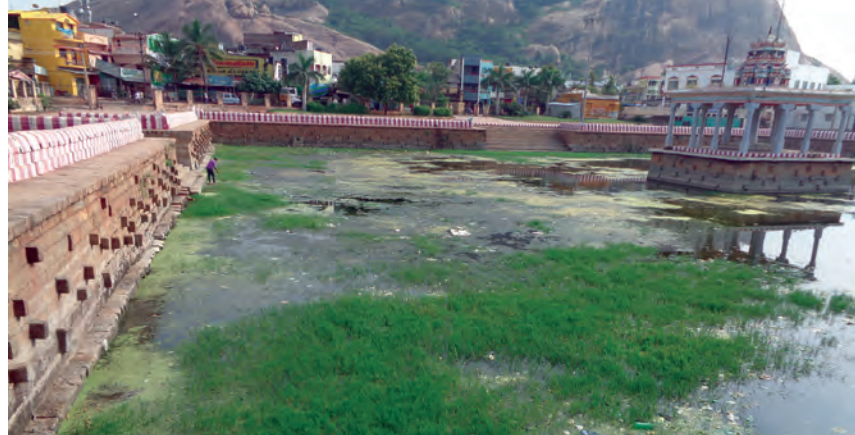
Thiruparankundram Theppam

Description of Infection: The tank water is highly infested with weed grass and algae. The tank is dumped with floatable and settle able solid wastes.

Functional Description: The temple tank is not accessed by communities. It is subjected to open defecation, despite the presence of a public toilet very close to the tank and household waste disposal by the neighbourhoods. The water in the tank is contributing to the ground water.

Recommendations: The temple tank must be desilted and cleaned. The common toilet which is located near to the temple tank should be repaired and functional, so that people will not access the tank for open defecation.

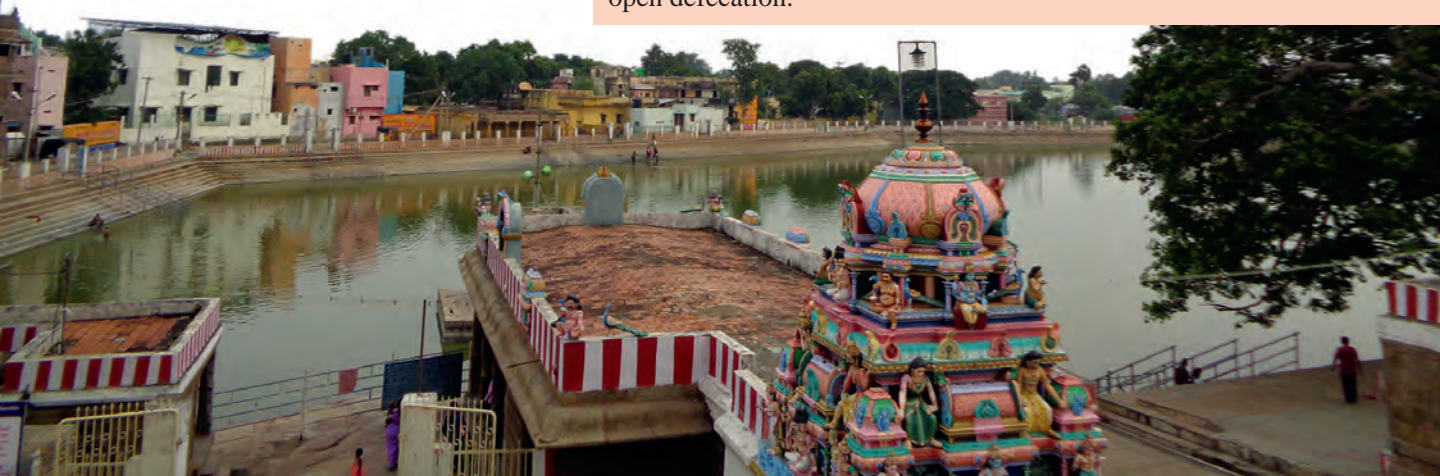
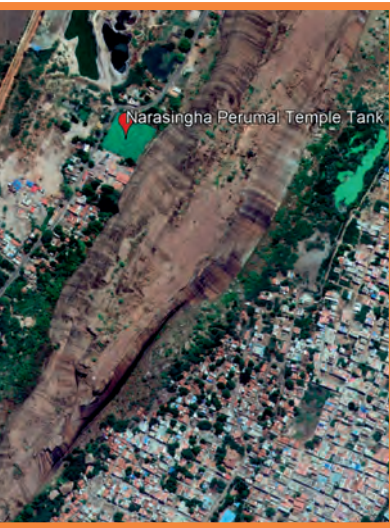
Sri Yoga Narasinga Perumal Temple Tank

Structural Description: The tank is constructed with stone masonry side walls. The temple is having access in all 4 directions via Ghats. The bondage between stone walls is poor resulting in dismantling of walls. The same has been seen with the steps in Ghats. The steps are poorly maintained and need to be repaired. The recent brick masonry retaining wall was also broken.

Description of Infection: About 90% of the temple tank is covered by lotus. This suffocates the carps in the tank water. Lot of fishes can be visualized near the Ghats where lotus is absent. Ritual Wastes are disposed by the devotees. Along with ritual materials, devotees dispose plastic bags too. This further complicates the ecosystem of the tank. The tank water is slight greenish in colour with floatation of oil, duck weeds and algae.

Recommendations: The tank is to be desilted and cleaned up to remove solid wastes. The stone walls and Ghats are to be repaired. The parapet walls are to be reconstructed. Appropriate ritual solid waste management has to be implemented. Lotus infestation has to be restricted to one third of the tank water spread area for better ecosystem.
