# Water Watch

**Urban Ooranis**

**The Fading 'blue green crucible'**

**Centre for Urban Water Resource (CURE)  
Water Knowledge Centre  
DHAN Vayalagam (Tank) Foundation**

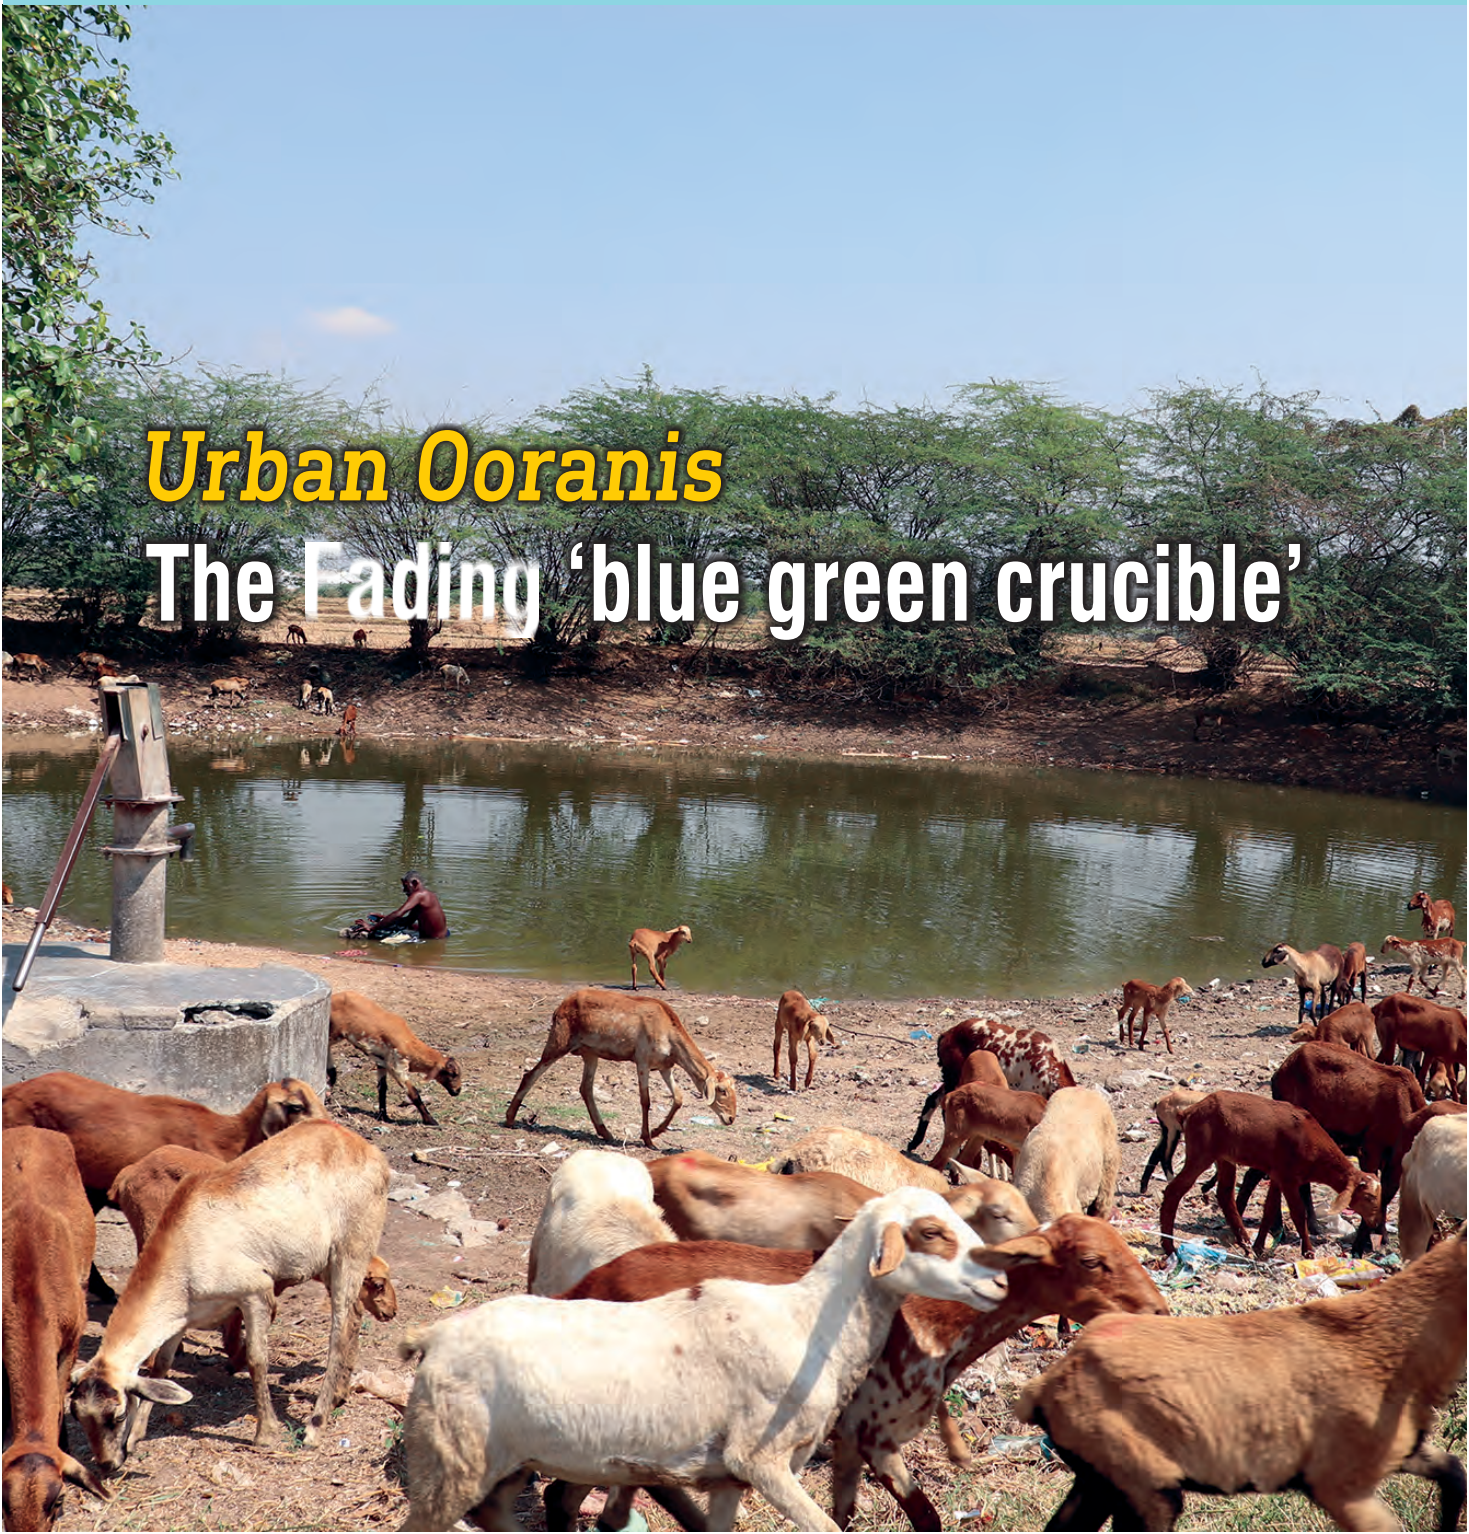
It is a wetland developed by mother 'nature' in a 'waste stabilisation pond' at Koodal Pudhur, Madurai. The pond is fed by raw sewage and septage whenever the inflow of sewage or septage is higher than the holding capacity of pumping station. The oorani is lined by stone masonry in the southern side and remains unlined in rest of the sides. It is not fenced. To avoid trespass, dry Prosopis are placed around the pond. Madurai corporation has to design the stabilisation pond as per the standards. It should be lined in all the directions and should be sealed at the bottom to avoid ground water pollution. The natural wetland that has formed in the oorani should be supported by providing artificial wetland spaces.

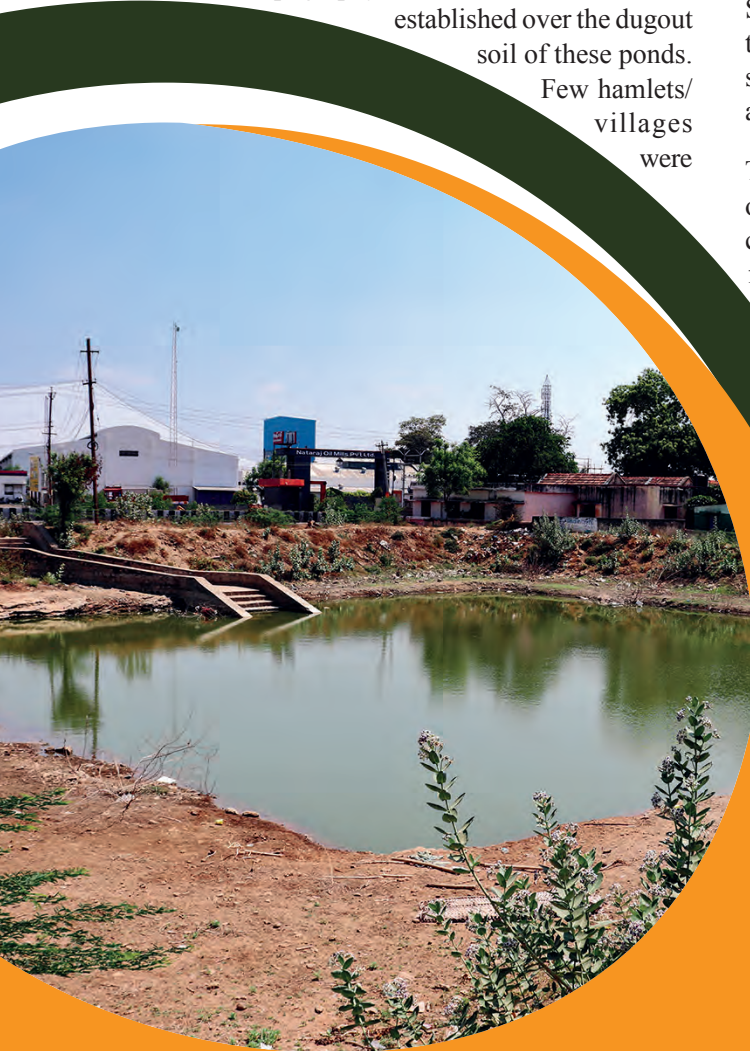
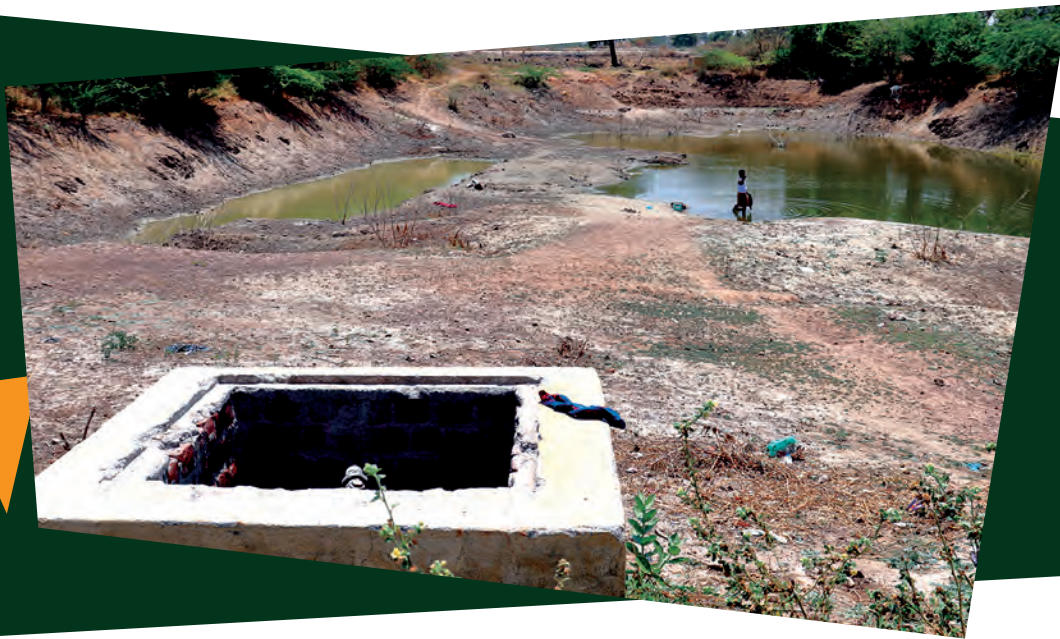
**Feeder channel** is the most critical component of oorani that ensures the source of water. In primitive stages feeder channels entered into the oorani through open cuts. As it led to erosion, sliding, difficulty in regulation of inflow leading to damage in bunds, inlet structure was constructed. A slow sand filter is provided at the inlet point which filters the storm water run-off effectively. Shutter was also provided in inlet structure to regulate the flow. Oorani with unregulated inlet has an

outlet structure such as waste weirs, conduits to release the surplus water. The surplus water either feeds neighbouring tanks or connects with the storm water drainage.

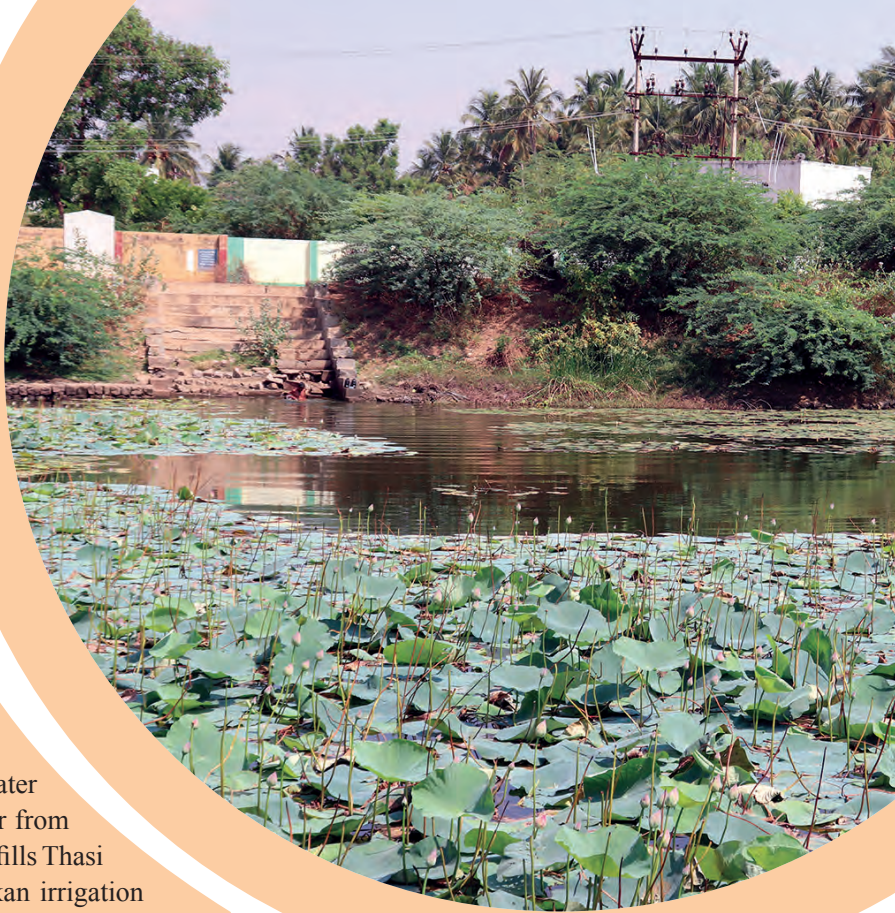
Though the bunds are planted with tree saplings under MGNRGA scheme, Prosopis infestation in the bunds

are suppressing the growth of the plantation. Except for the deepest excavation, rest of the area is covered by lotus which has been leased for flower harvest. The income from lease is used for village development and occasionally used for oorani restoration. A small permanent shed has been constructed (to place dead bodies), encroaching the periphery of the oorani.

The bund of oorani should be cleared from Prosopis infestation. Desilted soil from oorani should be used for strengthening bunds. Native trees should be planted along the same. The damaged steps of only Ghat shall be repaired. As the MGNRGA activities in Narasingham is laudable, they can be involved in restoration activities. A portion of income generated from lotus flower harvest should be invested back on the oorani for regular maintenance.

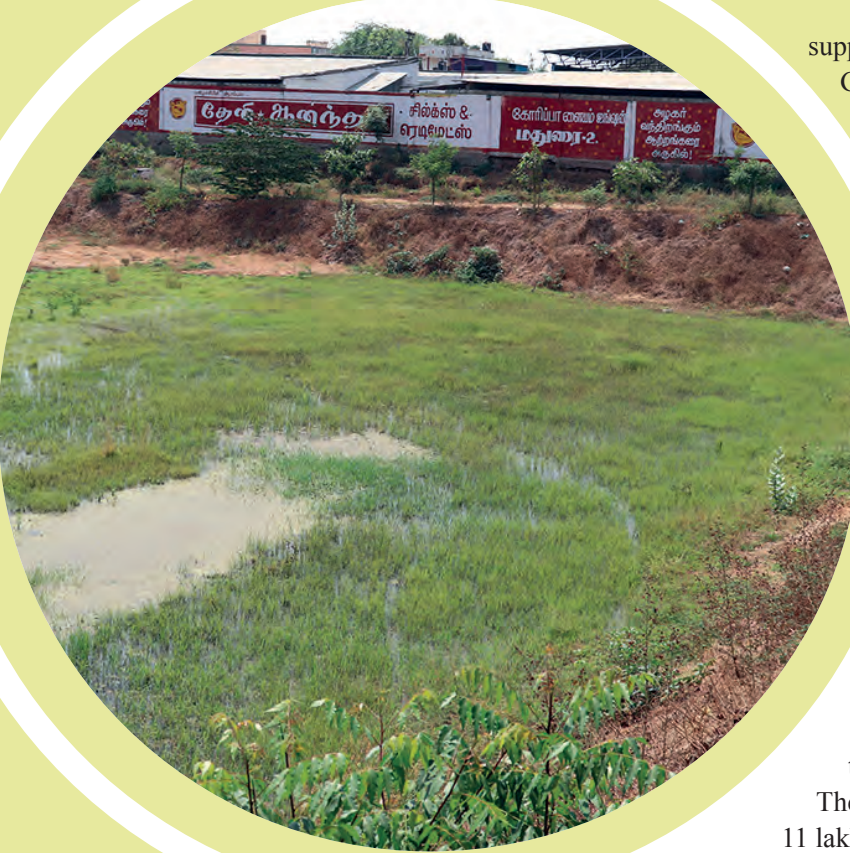
support of Ex- ward (56) counsellor and Gajendrapuram locales in July, 2018. Prosopis and reeds were cleared and fenced. About 30 native tree saplings such as Kadambam, Marutham, Neem, Pungai, etc. were planted in two sides of the ororani. The third side was planted with banana. The ororani is good example for creating green space in ororanis. A deep narrow pit was dug to store surplus water flowing from pumping station of ‘Integrated Cauvery drinking water project’ established in 2015-16. This stored surplus water is used for watering plants. The devotees and local people takes care of plants and water it. The overall restoration cost was about 11 lakhs.

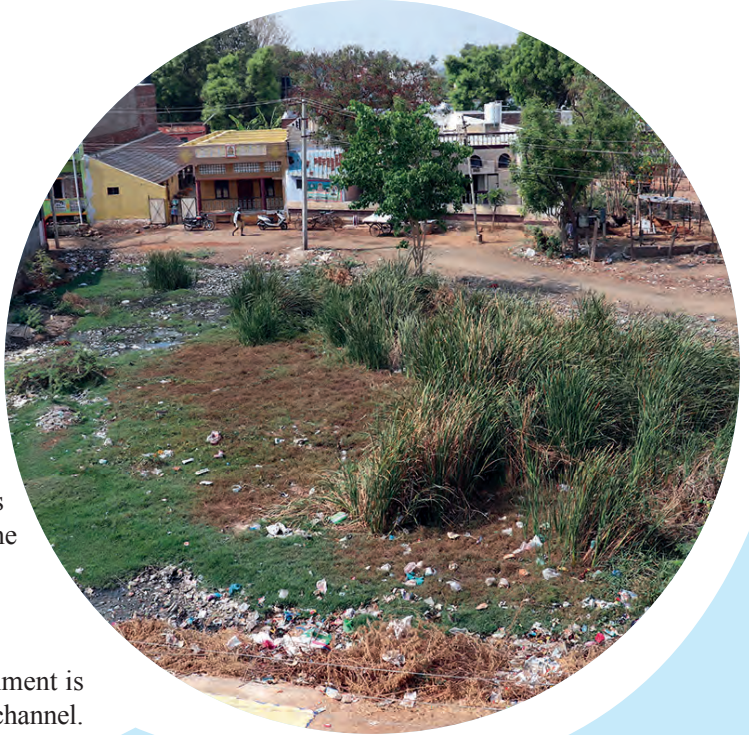
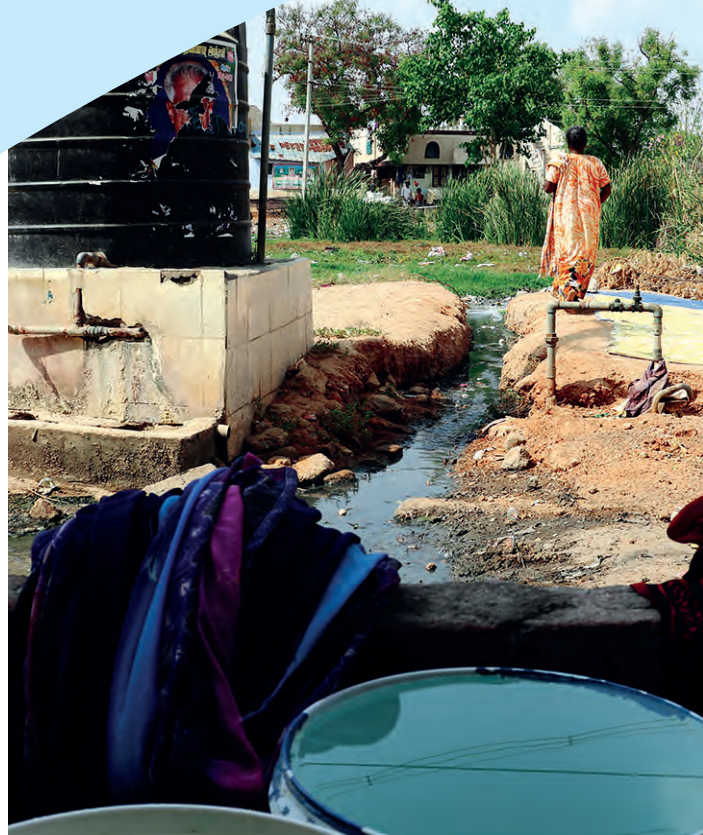
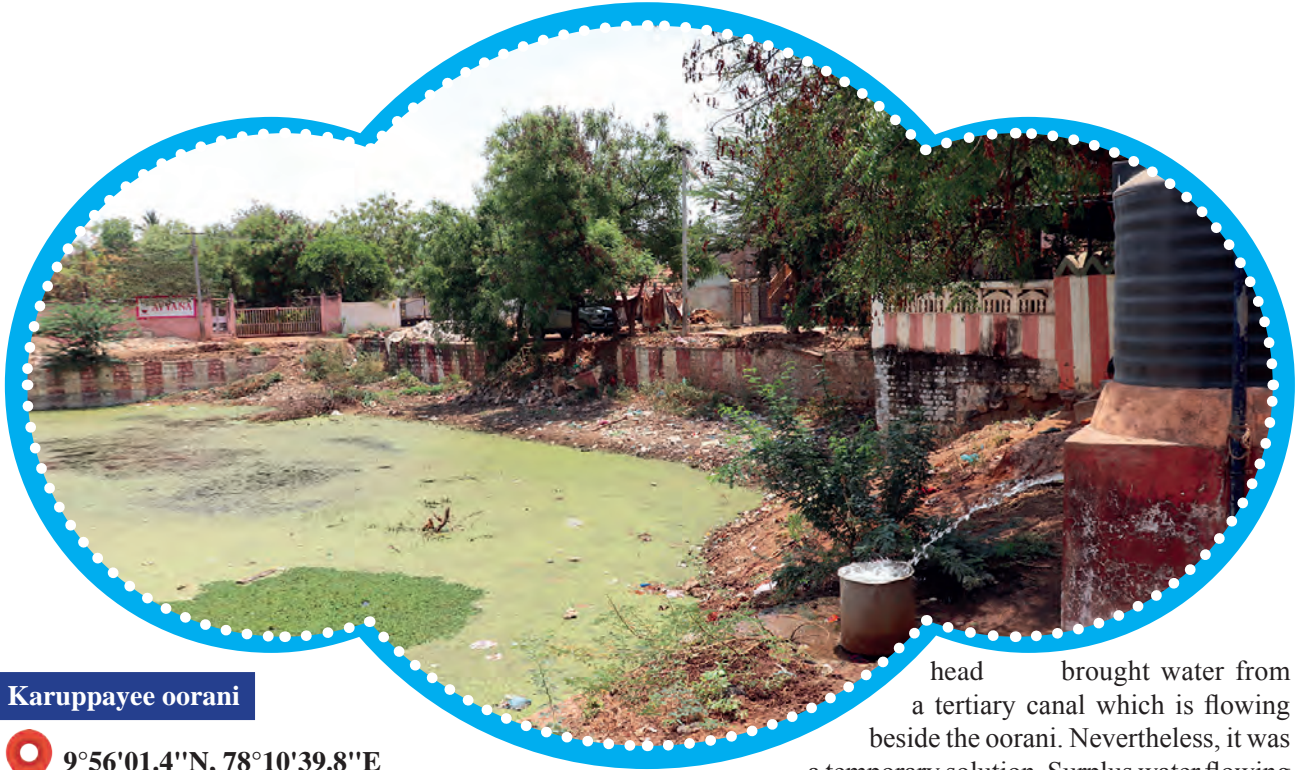
The oorani that received storm water from the catchment is currently receiving sewage flowing through its feeder channel. The raw sewage disposed is generated from the households around. Part of oorani was infested by reed and dumped with solid waste. Corporation has installed a pump setup to transfer sewage against slope from the oorani once it gets filed.

During rainy season (October 2018), the oorani was filled and the adjacent residential colony were inundated. Residents of this colony suffered from water borne diseases. The oorani water spread area has drastically shrunk from 0.68 acres to 0.27 acres. The major encroachers are Kaluvadiyan Kamatchi temple and local papad makers. There are information boards placed by temple authorities around the oorani stating that 'As per High Court Madurai Bench's order W.P.No. 8142/2011, Legal action will be taken against people who are disposing sewage or solid waste in the oorani that belongs to the temple'. But there is a case in National Green Tribunal regarding ownership of the oorani between Madurai City corporation and the temple authorities.

Madurai South Tahsildar should demarcate the oorani boundary and evict the encroachments immediately. As the oorani has lost its storage capacity due to filthy disposals, it should be desilted and deepened so that during heavy rainfalls, the locales will not suffer due to inundation. Followed by it Madurai Corporation should come forward for installation of underground drainage system or should think of some decentralised alternatives such as Decentralised Wastewater Treatment System (DEWATS), reed bed system, constructed wetlands, etc. to treat the sewage locally before disposing into the oorani. The oorani should be fenced to avoid encroachment and sufficient dumper bins should be provided to dispose, collect and manage solid waste effectively.

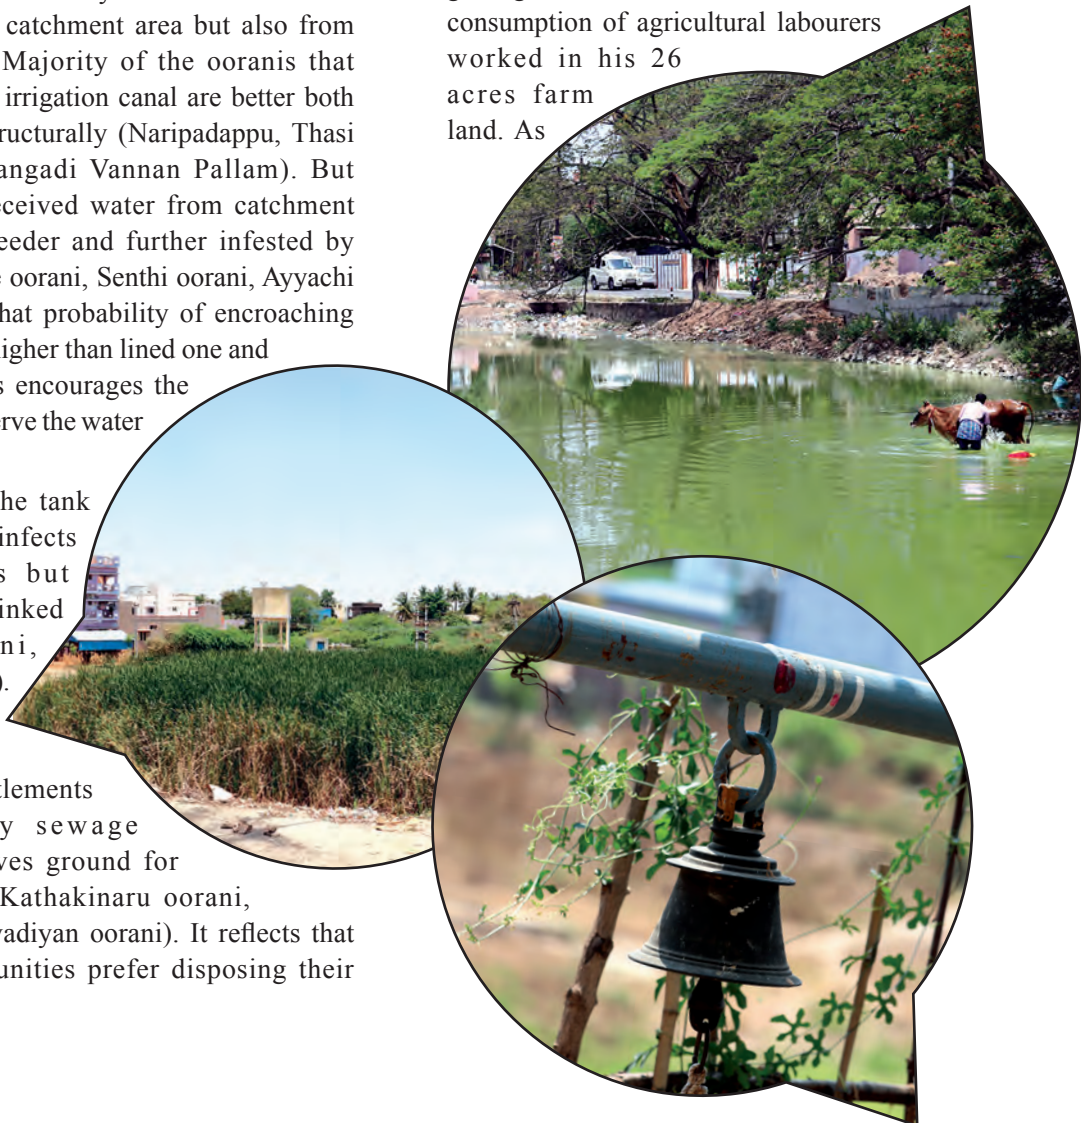
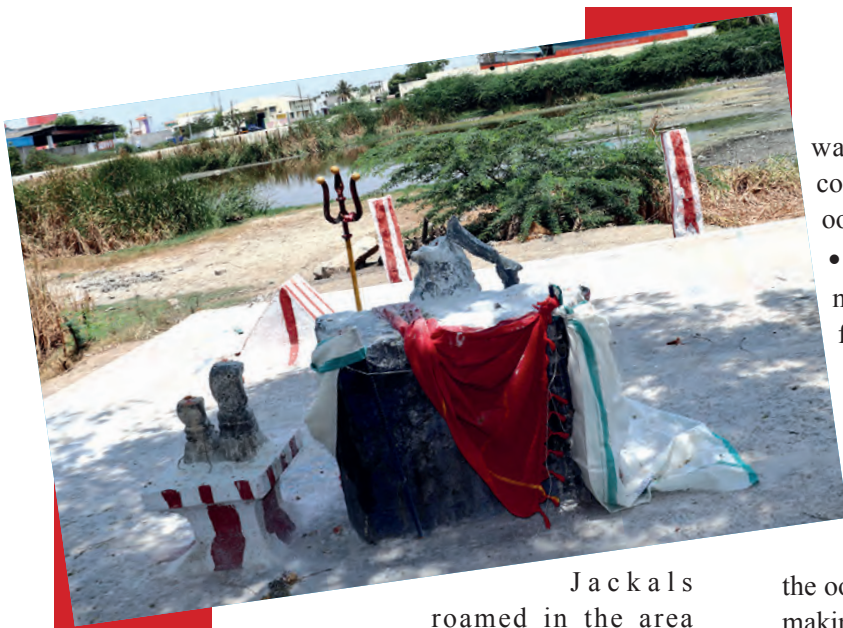
- Naripadappu Oorani in Valar Nagar is a private oorani belonging to Mr.Dhiraviyam pillai whose great grandfather constructed this oorani for consumption of agricultural labourers worked in his 26 acres farm land. As

Jackals roamed in the area prior to oorani establishment, he named it as Naripadappu. Oorani is filed post irrigating the agricultural land. Whenever there is a shortage in irrigation at later stages, the oorani water is used. At present, Mr.Dhiraviyam holds just 3 acres. Therefore, he feels that the oorani is no more profitable, despite fish rearing. He is planning to fill up the dugout and convert it into residential plot.
