Water *Watch*

Understanding the
VIZAG'S WATERBODIES

This Water Watch by Centre for Urban Water Resources (CURE), DHAN Foundation is a contribution to the noval Eco-Vizag Campaign; Particularly to the Eco-Blue Component.

3.0 Present Status of water bodies in Visakhapatnam:

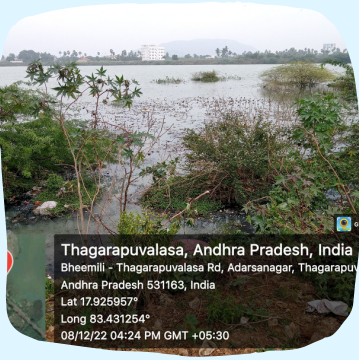
Thagarapuvalasa, Andhra Pradesh, India
 Bheemili - Thagarapuvalasa Rd, Adarsanagar, Thagarapu
 Andhra Pradesh 531163, India
 Lat 17.925957°
 Long 83.431254°
 08/12/22 04:24 PM GMT +05:30

Name of the Pond: **Citivalasa Chilapetta Cheruvu**
 Area: Citivalasa
 Ward No: 1
Specification: One of the biggest water bodies of GVMC. The whole Bheemlipatinam settlements are around the waterbody. heavy sewage inflow.
Present Condition: Invasive species both Prosopis and water Hycianth are present. Bund strengthening is needed in concern to act as a better flood carrier.

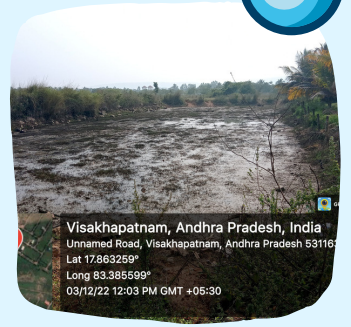
Visakhapatnam, Andhra Pradesh, India
 Unnamed Road, Visakhapatnam, Andhra Pradesh 531163
 Lat 17.863259°
 Long 83.385599°
 03/12/22 12:03 PM GMT +05:30

Name of the Pond: **Kaladapalem cheruvu**
 Area: Boyapalem
 Ward No: 4
Specification: Rocky base surface with stone bunding which holds very less water.
Present Condition: Waterbody is fenced by the private.

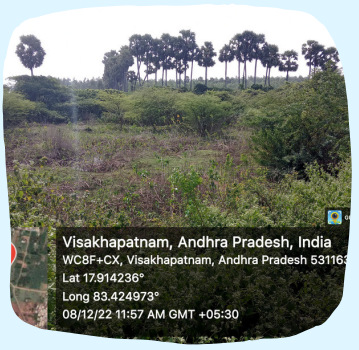
Visakhapatnam, Andhra Pradesh, India
 WC8F+CX, Visakhapatnam, Andhra Pradesh 531163
 Lat 17.914236°
 Long 83.424973°
 08/12/22 11:57 AM GMT +05:30

Name of the Pond: **Chilapaiya Cheruvu**
 Area: Nimmdipette
 Ward No: 2
Specification: Located in the centre of the road junction. Act as the flood carrier. More Construction debris is dumped in the water bodies.
Present Condition: Heavily silted and Invasion. Need of desilting and bund strengthening.

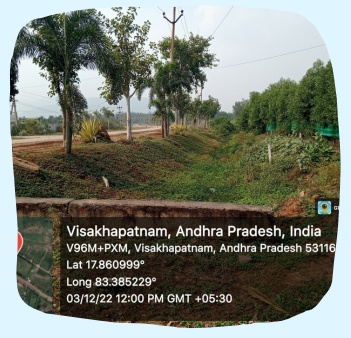
Visakhapatnam, Andhra Pradesh, India
 V96M+PXM, Visakhapatnam, Andhra Pradesh 531163
 Lat 17.860999°
 Long 83.385229°
 03/12/22 12:00 PM GMT +05:30

Name of the Pond: **Nathipaidaiyu cheruvu**
 Area: Koppulupada area
 Ward No: 4
Specification: waterbody is present in the channel area.
Present Condition: Waterbody is acting as the storm drain.

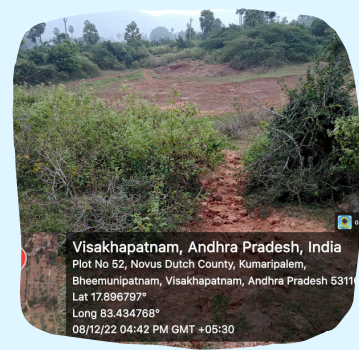
Visakhapatnam, Andhra Pradesh, India
 Plot No 52, Novus Dutch County, Kumarapalem,
 Bheemunipatnam, Visakhapatnam, Andhra Pradesh 531163
 Lat 17.896797°
 Long 83.434788°
 08/12/22 04:42 PM GMT +05:30

Name of the Pond: **Gayathrigudi Cheruvu**
 Area: Kumarapalem
 Ward No: 2
Specification: A Square-shaped Pond acts as the flood carrier. The surrounding areas are developing in the fast phase.
Present Condition: urgent Desilting, Bund strengthening is needed for future flood regulators.

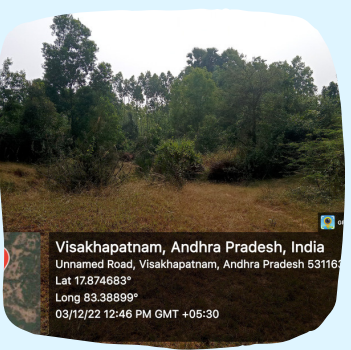
Visakhapatnam, Andhra Pradesh, India
 Unnamed Road, Visakhapatnam, Andhra Pradesh 531163
 Lat 17.874683°
 Long 83.38899°
 03/12/22 12:46 PM GMT +05:30

Name of the Pond: **Tadi Gedda**
 Area: Kothavalasa
 Ward No: 4
Specification: Surrounded by Agricultural land. natural bund formation pattern is available.
Present Condition: Heavily silted, Water holding capacity is very less.

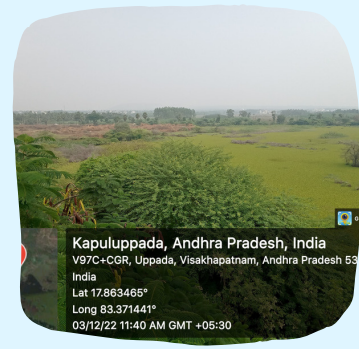
Kapulupada, Andhra Pradesh, India
 V87C+CGR, Uppada, Visakhapatnam, Andhra Pradesh 531163
 India
 Lat 17.863465°
 Long 83.371441°
 03/12/22 11:40 AM GMT +05:30

Name of the Pond: **Boyapalem**
 Area: Jeyendhra colony boyapaleam
 Ward No: 4
Specification: Long bund with pockets of agriculture. No sluices are surplus found.
Present Condition: Biggest waterbody with 100% invasive species like water hyacinth and bunds are high prosopis invasion

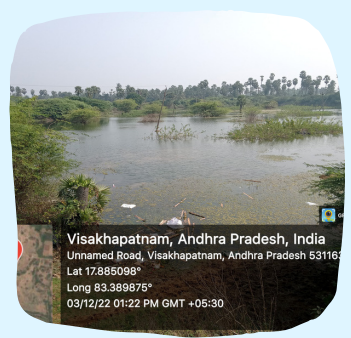
Visakhapatnam, Andhra Pradesh, India
 Unnamed Road, Visakhapatnam, Andhra Pradesh 531163
 Lat 17.885098°
 Long 83.389875°
 03/12/22 01:22 PM GMT +05:30

Name of the Pond: **Bodlapalem Cheruvu**
 Area: Bodlapalem
 Ward No: 4
Specification: A fully functional irrigation pond with siltation and invasive species.
Present Condition: The partial command area is converted into plots. The purpose of waterbody is slowly deteriorating.

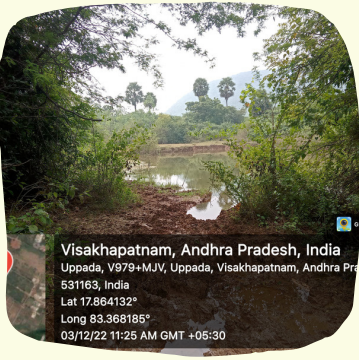
Name of the Pond: **Padradesipaleam Cheruvu**
 Area: Paradesipalem
 Ward No: 4
Specification: Heavy Siltation with more invasive Species and the eroded bund
Present Condition: Immediate desilting and Bund strengthening are in need to arrest the flood drain.

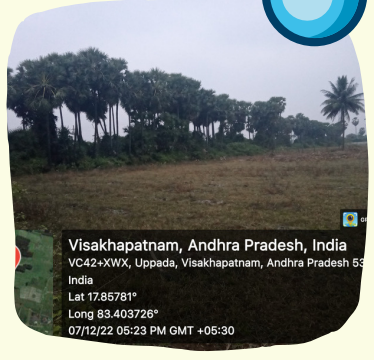
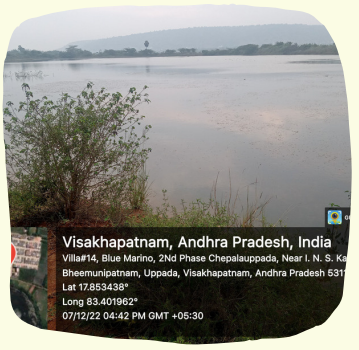
Name of the Pond: Devula Cheruvu
 Area: Uppada
 Ward No: 4
Specification: The twin waterbody is located near to big residential complex of Villas. The waterbody is cut by the road, One side is well maintained and the other side is complete with invasion.
Present Condition: Prosopis removal and desilting off waterbody is needed.

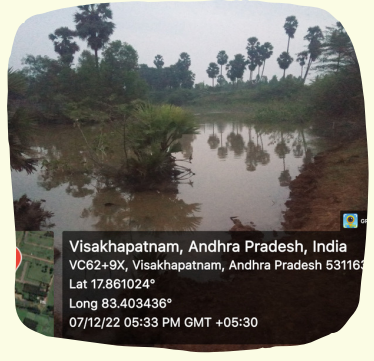
Name of the Pond: **Khambala Cheruvu**
 Area: Nagarpalem
 Ward No: 4
Specification: One of the biggest pond. Effectively utilized for agriculture
Present Condition: Prosopis removal is necessary for the bund, Surplus weirs need to be restored.

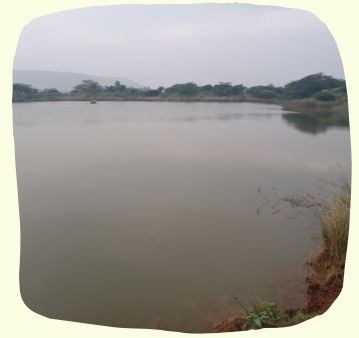
Name of the Pond: **Nerla Cheruvu**
 Area: Nerlavarsa
 Ward No: 4
Specification: The land use and land cover of the surrounding area to the waterbody is completely changed into residential plots. But the waterbody remains biodiversity-rich.
Present Condition: Desilting and invasion removal are necessary. This may be converted as a recreational spot.

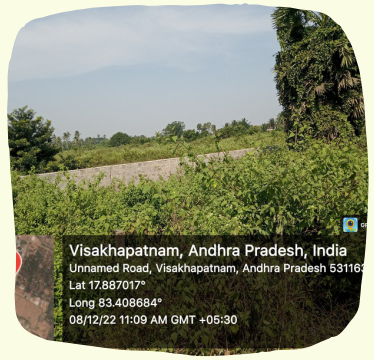
Name of the Pond: **Kotha Cheruvu**
 Area: Uppada
 Ward No: 4
Specification: One of the biggest ponds like Khambala Cheruvu. Effectively utilized for agriculture
Present Condition: Prosopis removal is necessary for the bund, Surplus weirs need to be restored.

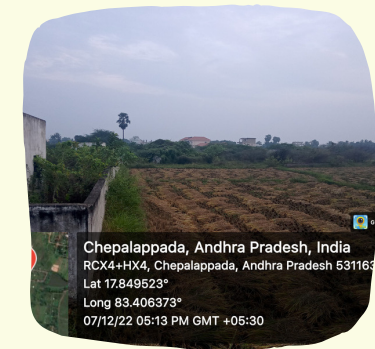
Name of the Pond: **Borapetta Pond**
 Area: J V Agrohram Borapetta
 Ward No: 4
Specification: Landuse is changed. Compound constructed
Present Condition: Lost waterbody..

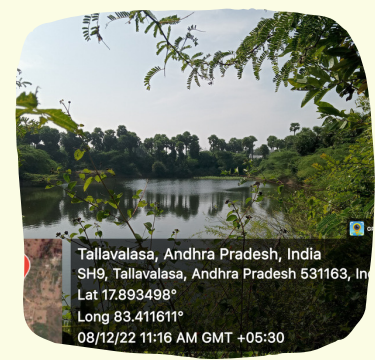
Name of the Pond: **Marricheruvu**
 Area: Uppada
 Ward No: 4
Specification: located in a highly developing area. Due to the effective catchment area, Water presence is mostly at FTL
Present Condition: Desilting and Bund strengthening is needed to ensure effective storage

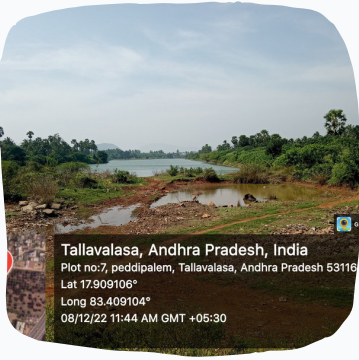
Name of the Pond: **Chimaiya Cheruvu**
 Area: Tallavalasa
 Ward No: 4
Specification: Biodiversity-rich waterbody. the potential mix of poultry waste which is close to the bund.
Present Condition: Bunds are with the heavy invasion of Prosopis. desilting is needed to retain its original shape.

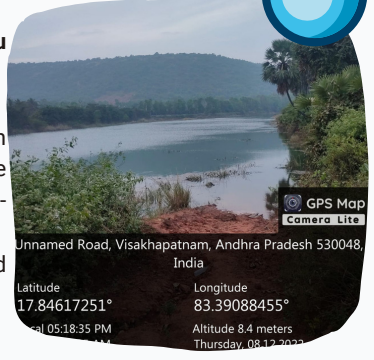
Name of the Pond: **Bangarammathalli Cheruvu**
 Area: Tallavalasa
 Ward No: 4
Specification: located exactly in the GVMC border, long bund with fish culture.
Present Condition: well maintained and highly invested waterbody.

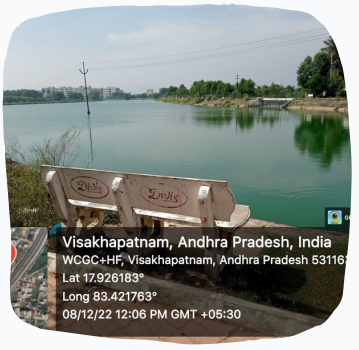
Name of the Pond: **Pedda Cheruvu**
 Area: Radilapalem
 Ward No: 4
Specification: A big waterbody with a command area. Orchards are the growing trend in this area. A well-maintained one.
Present Condition: Effectively used for agriculture

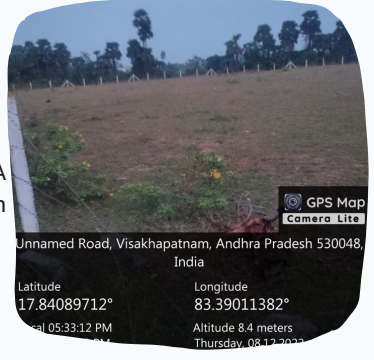
Name of the Pond: **Kondaa Tank**
 Area: Tallavalasa
 Ward No: 4
Specification: Acts as the flood carrier, Bunds are completely stone-pitched with concrete. Huge drain issue in the Surplus course.
Present Condition: Huge investments of about 2 crores are Spent by CSR. Acts as a better recreation spot

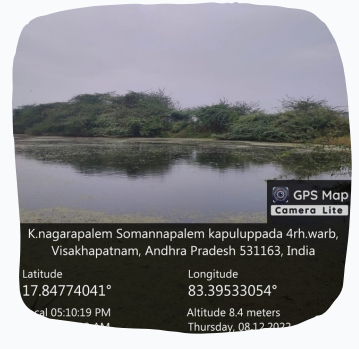
Name of the Pond: **Gedda layout**
 Area: K.uppada
 Ward No: 4
Specification: Fenced by VMDRA and declared as the urban expansion layout
Present Condition: Lost waterbody

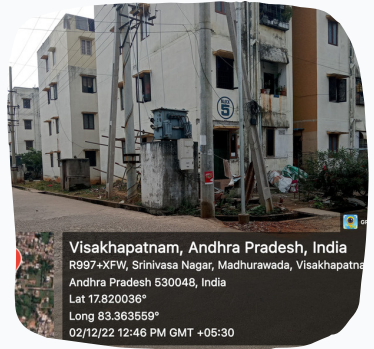
Name of the Pond: **Badava Cheruvu**
 Area: Radilapalem
 Ward No: 4
Specification: fully covered with agricultural land. High potential waterbody for agriculture. High possibility of encroached cultivation.
Present Condition: Bunds are with the high invasion of the Prosopis Juiflora Invasion. Desilting of the tank is necessary.

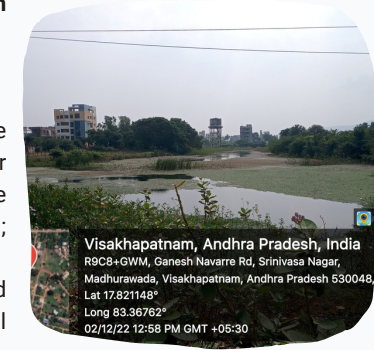
Name of the Pond: **Ootapalem Cheruvu**
 Area: Radilapalem
 Ward No: 4
Specification: A big waterbody with a command area. Paddy cultivation at the command area.
Present Condition: Heavy sewage inflow. 100% covered with the water hyacinth. Bunds are at the road level. serious need for desilting and arresting sewage inflow.

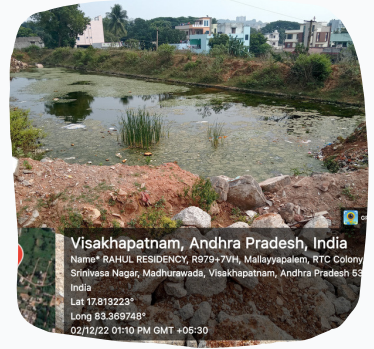
Name of the Pond: **Botavanipalen Cheruvu**
 Area: Botavanipalen
 Ward No: 5
Specification: High sewage flow due to No UGD connection for apartments; waterbody is with more invasive species, Bunds are eroded; No command area
Present Condition: Sewage and construction debris are found in all directions of tank.

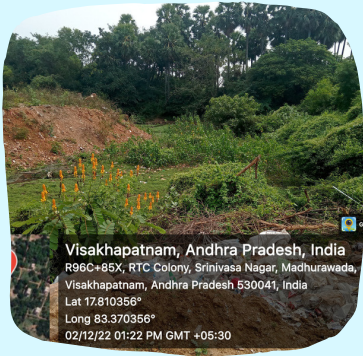
Name of the Pond: **RTC colony Cheruvu**
 Area: Malliyapalem RTC colony
 Ward No: 5
Specification: sewage-fed waterbody desilting. Deep sand mining happened.
Present Condition: Spot for dumping the construction debris and acting as the sewage carrier.

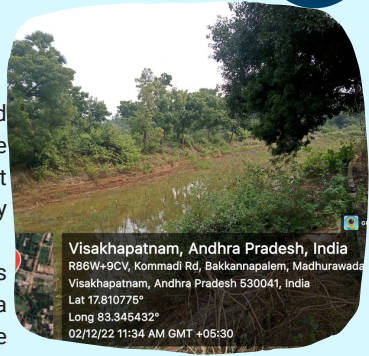
Name of the Pond: ***not identified**
 Area: RTC colony
 Ward No: 5
Specification: Heavily silted and the land is recovered from the encroachment. The less water spread area is act as the sewage carrier
Present Condition: The board is installed in the name of the District Magistrate to stop the encroachment. Immediate restoration is needed.

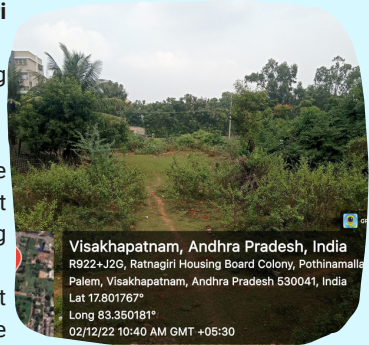
Name of the Pond: **Madurawada Cheruvu**
 Area: Madurawada
 Ward No: 5
Specification: From 1979 onwards, The water spread area is converted as Zilla Parishad High School
Present Condition: Lost water body

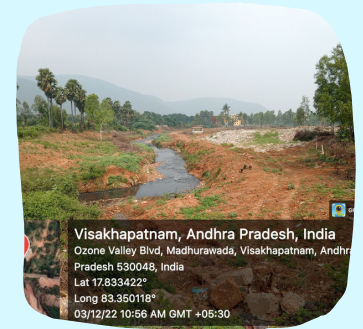
Name of the Pond: **Rathanagiri housing board Cheruvu**
 Area: Ysr station PM Palam housing board colony
 Ward No: 6
Specification: Located in the housing board area, Locals predict that this land is sold to Housing Board in the early 80s.
Present Condition: Waterboy doesn't exist but due to low elevation, the slurry and the Pig Population are evident for the waterbody.

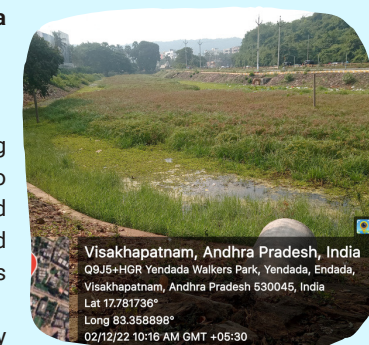
Name of the Pond: **Komathi chinna cheruvu**
 Area: Komathi village
 Ward No: 6
Specification: Recently Bund got strengthened. Pipe-based sluices are present.
Present Condition: This waterbody still has a command area. Due to Pisciculture & irrigation, this waterbody still creates livelihood opportunities

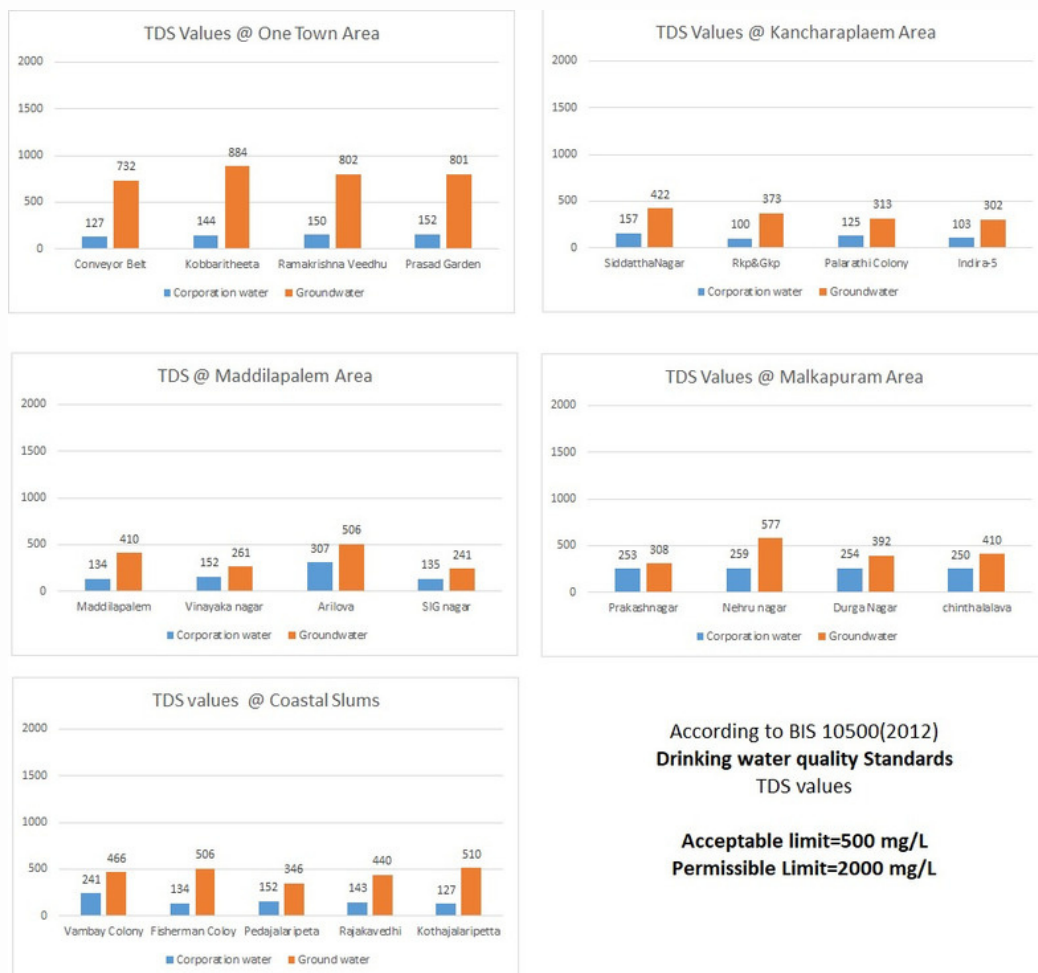
Inferences: The Corporation supplied water is safe and healthy for drinking where values are ranges from 100mg/L to 250mg/L. Most of the Groundwater are crossing the acceptable limits;Filtration is needed before consuming the Groundwater.
