October 2018

Water *Watch*

Withdrawn Red Alert
Threat Remains

Centre for Urban Water Resource (CURE)
Water Knowledge Centre
DHAN Vayalagam (Tank) Foundation

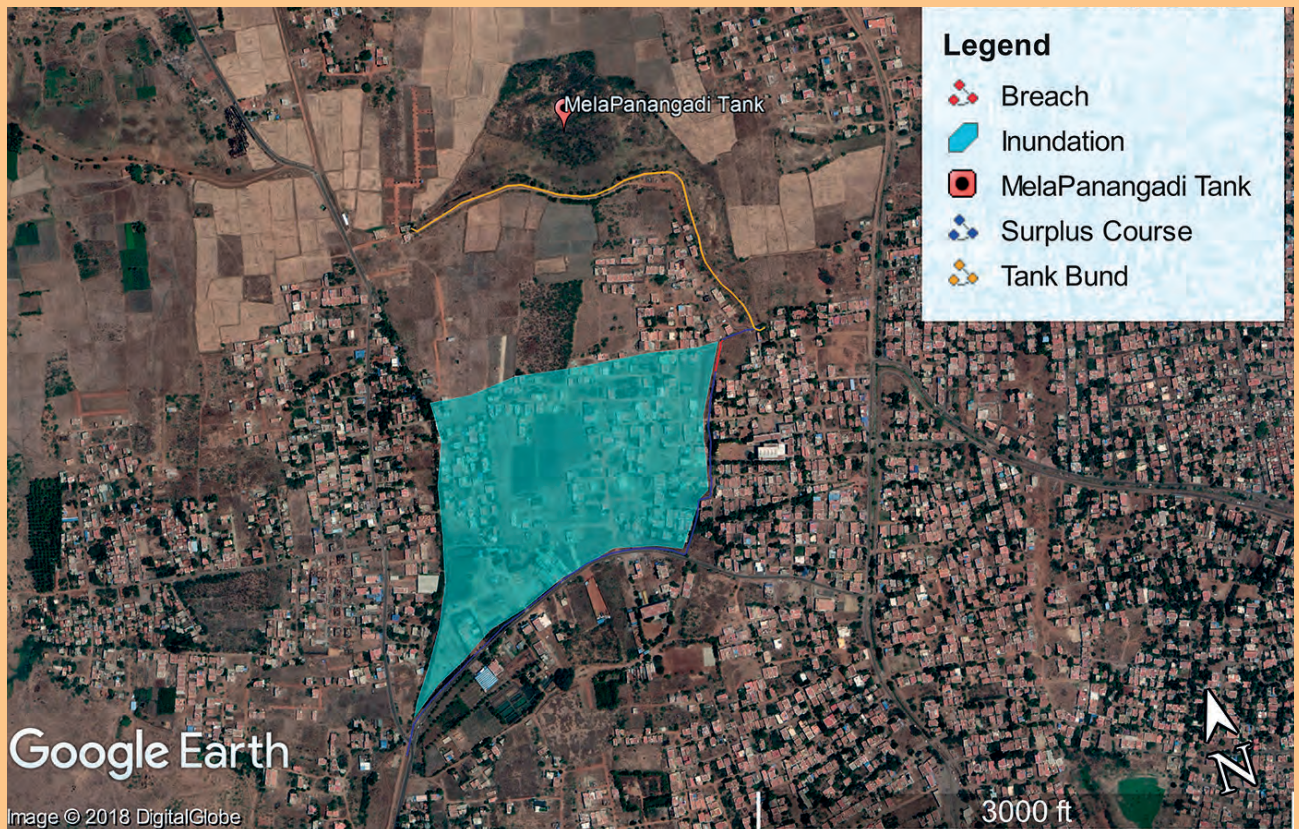
North Madurai was affected due to the rainfall because both Vandiyur and Sellur tank cascades of Satiyar Sub basin falls under this region. Surplus of both the cascades are drained into River Vaigai. About 8% of the total Land use Area of Madurai North (Corporation Boundary) is tank. Madurai City is gifted with Tank system; wisdom of ancestors; the best flood moderator.

Despite of recent tank rehabilitation carried out by the Public Administration, there were breaches, inundations and sufferings. This water watch focuses about response of Madurai and its tank system for the October rainfall; a warning rainfall; an evaluator in disguise.

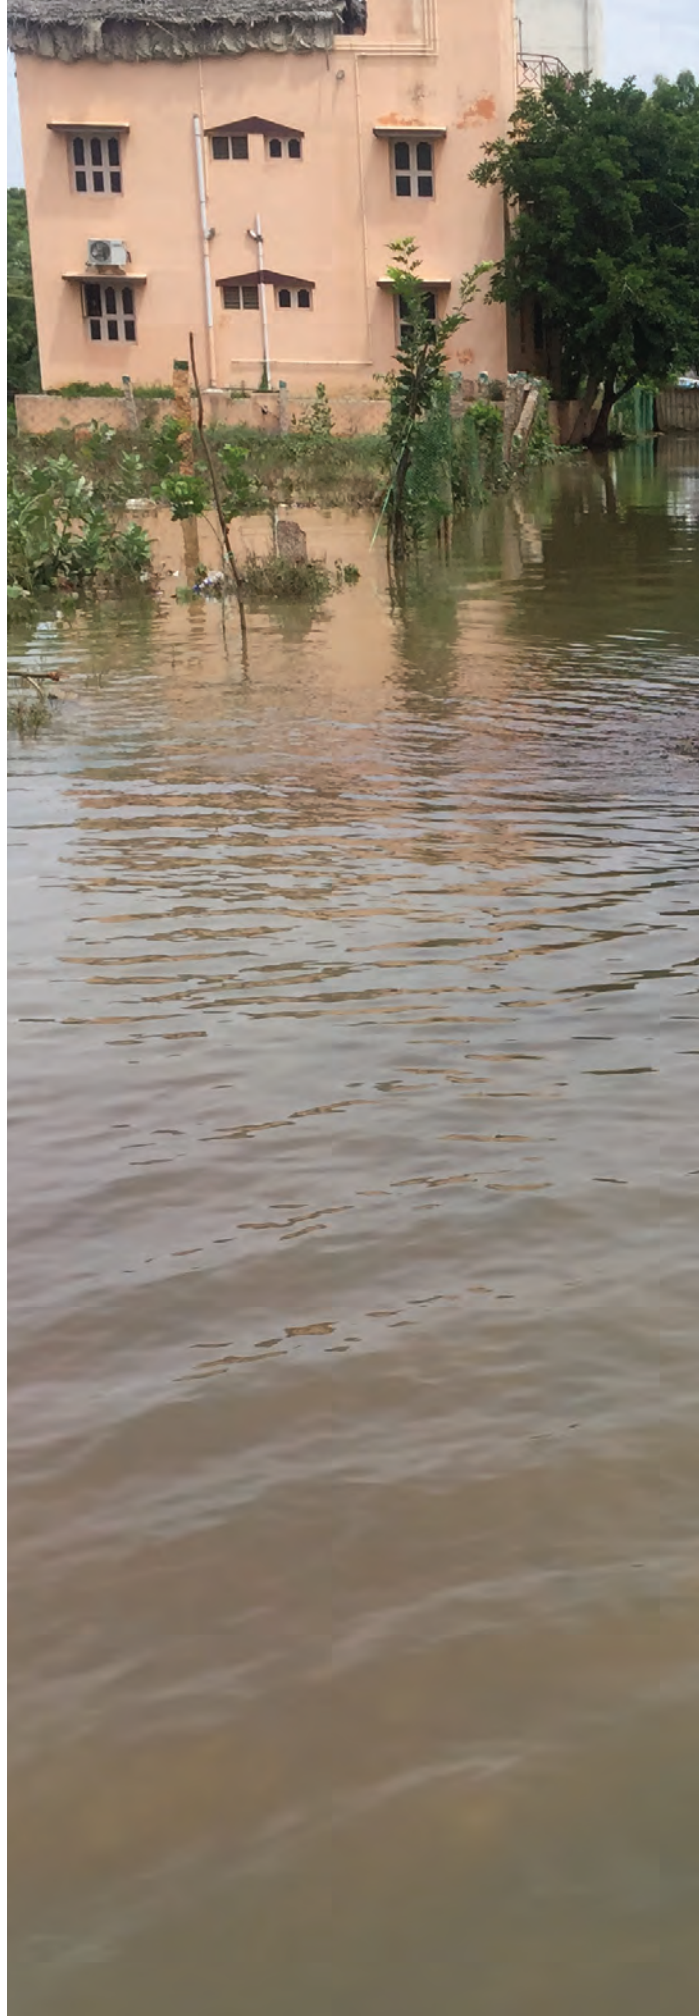
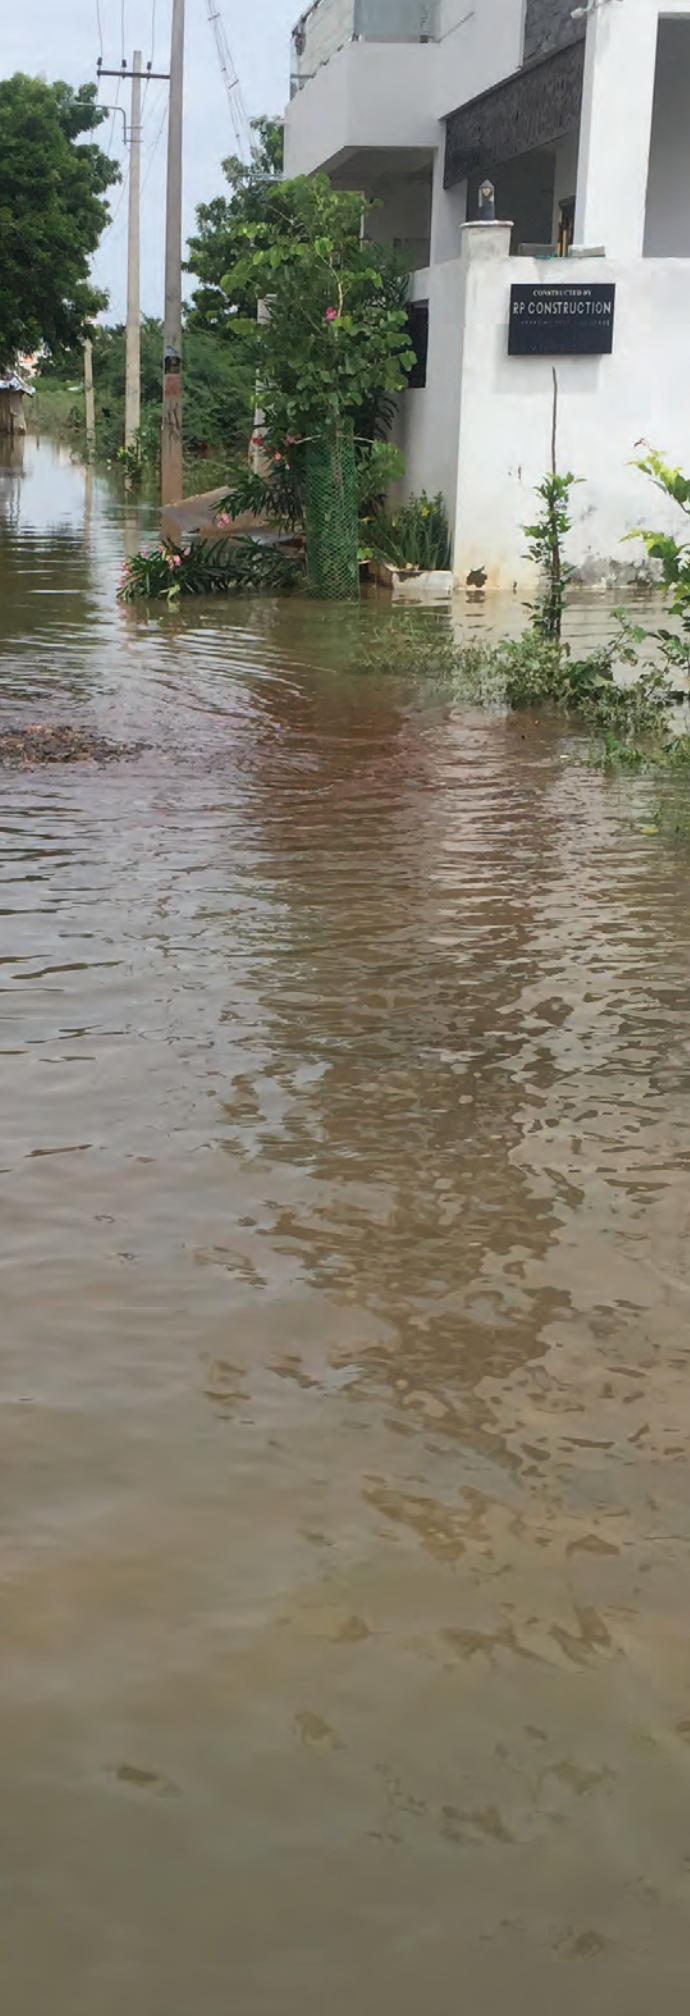
Reasons for Inundation

1. There is a sharp 90 degree turn in the Kodikulam surplus course. As sharp curve is the weakest point, to avoid breach the curve was strengthened by stone pitching in the left embankment. But the

stone pitching got deteriorated over the period. This deterioration resulted in breach in the left bank post the sharp curve. This breach was the main reason behind inundation.

2. There was another breach in the confluence point of Surplus courses from Kodikulam Tank and Parasurampatti tank. This was mainly because of poor water carrying capacity of both the channels.
3. There was one more breach in the southern part of TM Nagar, opposite to Meenakshi Mission Hospital. This was mainly due to back flow of Uthangudi surplus course caused by heavy flow in Parasurampatti surplus course.
4. Low carrying capacity of the surplus courses was mainly due to reduction in channel cross area. This was mainly due to siltation of channel, Prosopis and reed invasion in the channels and encroachment of the same.
