Water *Watch*

Quality Matters

Temple tank
A blue structure

Temple Tanks – Blue spots in Concrete Urban Fabrics!

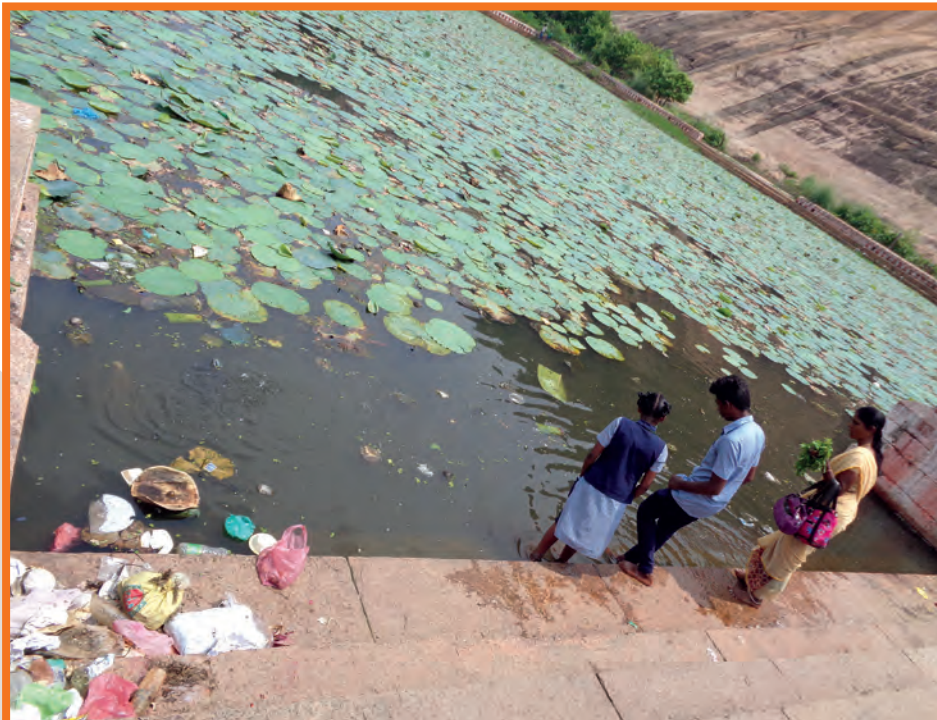
Structural Description: The tank is constructed with stone masonry side walls. The temple is having access in all 4 directions via Ghats. The bondage between stone walls is poor resulting in dismantling of walls. The same has been seen with the steps in Ghats. The steps are poorly maintained and need to be repaired. The recent brick masonry retaining wall was also broken.

Functional Description: The tank is leased every three years for lotus. Though local beliefs are against fishing, deprived communities do fishing from the temple tank. The entire tank was cleaned about 10 years ago for the temple kumbabishegam. The water is used for ritual purposes only. The groundwater contribution of the tank is minimal due to the rock bed.

Recommendations: The tank is to be desilted and cleaned up to remove solid wastes. The stone walls and Ghats are to be repaired. The parapet walls are to be reconstructed. Appropriate ritual solid waste management has to be implemented. Lotus infestation has to be restricted to one third of the tank water spread area for better ecosystem.

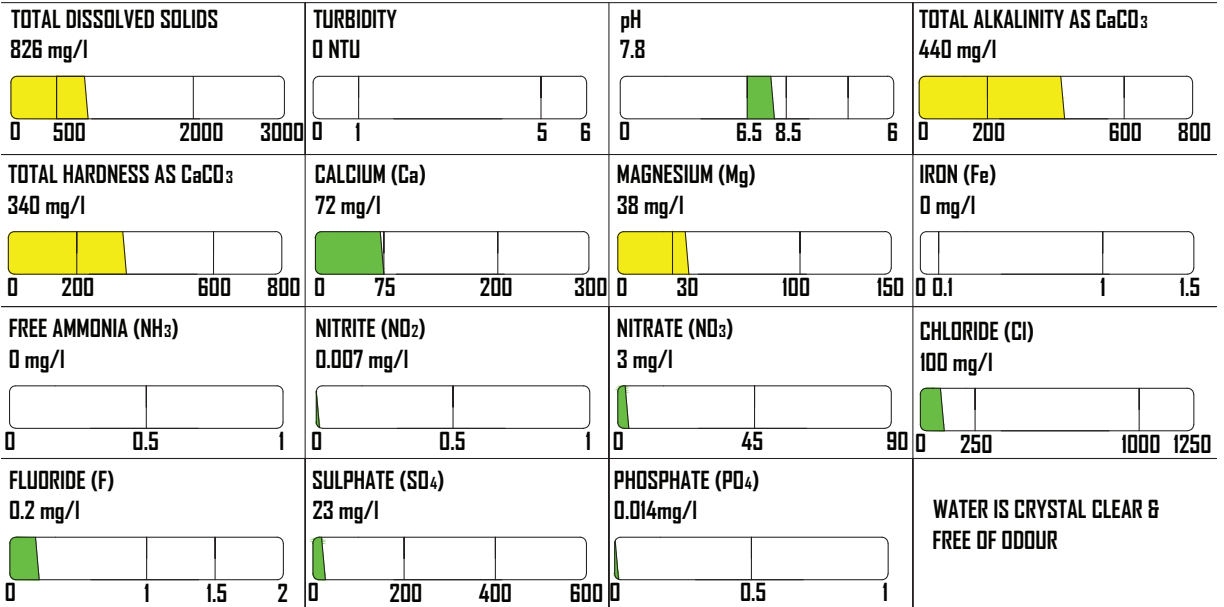
Zone 2 - Ground Water

IT IS OBSERVED THAT WATER IS HARD BECAUSE OF THE PRESENCE OF CALCIUM AND MAGNESIUM. TOTAL DISSOLVED SOLIDS(TDS) EXCEEDS ACCEPTABLE LIMIT. IT DOES NOT HAVE DIRECT HEALTH EFFECTS BUT SOLIDS WHICH CAUSES HIGHER 'TDS' MAY BE HARMFUL TO HUMAN HEALTH. THIS WATER IS **NOT** RECOMMENDED FOR DRINKING. BUT IF THERE IS NO OTHER SOURCE OF DRINKING WATER, THEN IT SHALL BE CONSUMED.

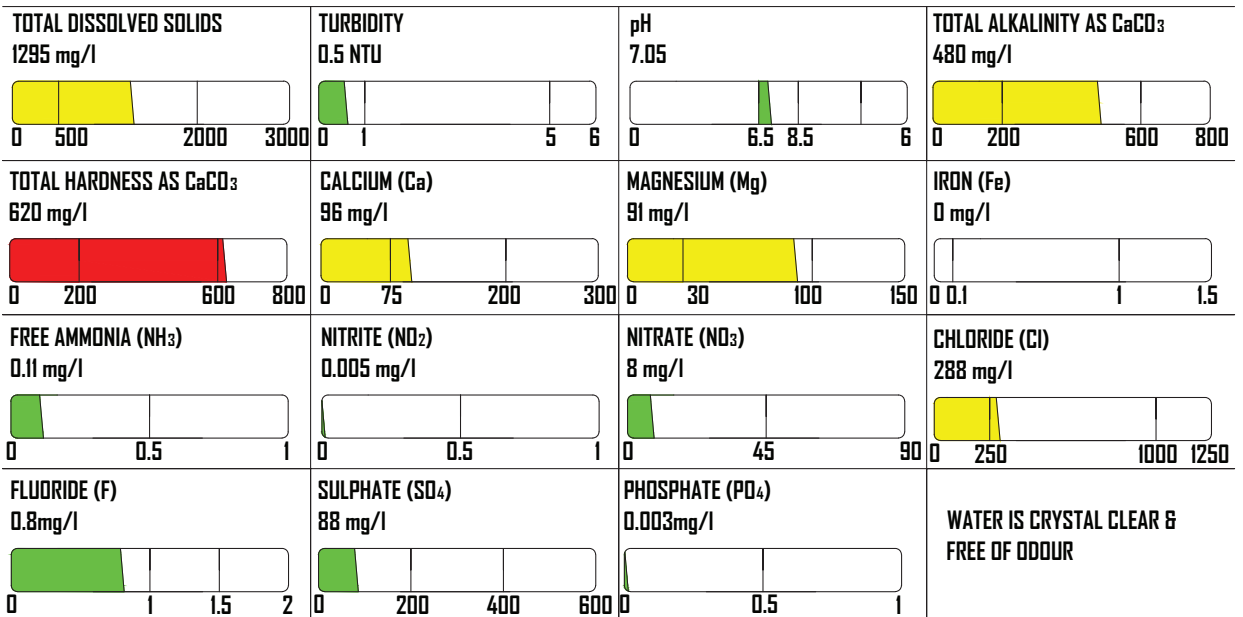
Zone 3 - Ground Water

IT IS OBSERVED THAT WATER IS HARD BECAUSE OF THE PRESENCE OF CALCIUM AND MAGNESIUM. TOTAL DISSOLVED SOLIDS(TDS) EXCEEDS PERMISSIBLE LIMIT. IT DOES NOT HAVE DIRECT HEALTH EFFECTS BUT SOLIDS WHICH CAUSES HIGHER 'TDS' MAY BE HARMFUL TO HUMAN HEALTH. THIS WATER IS **NOT** RECOMMENDED FOR DRINKING.

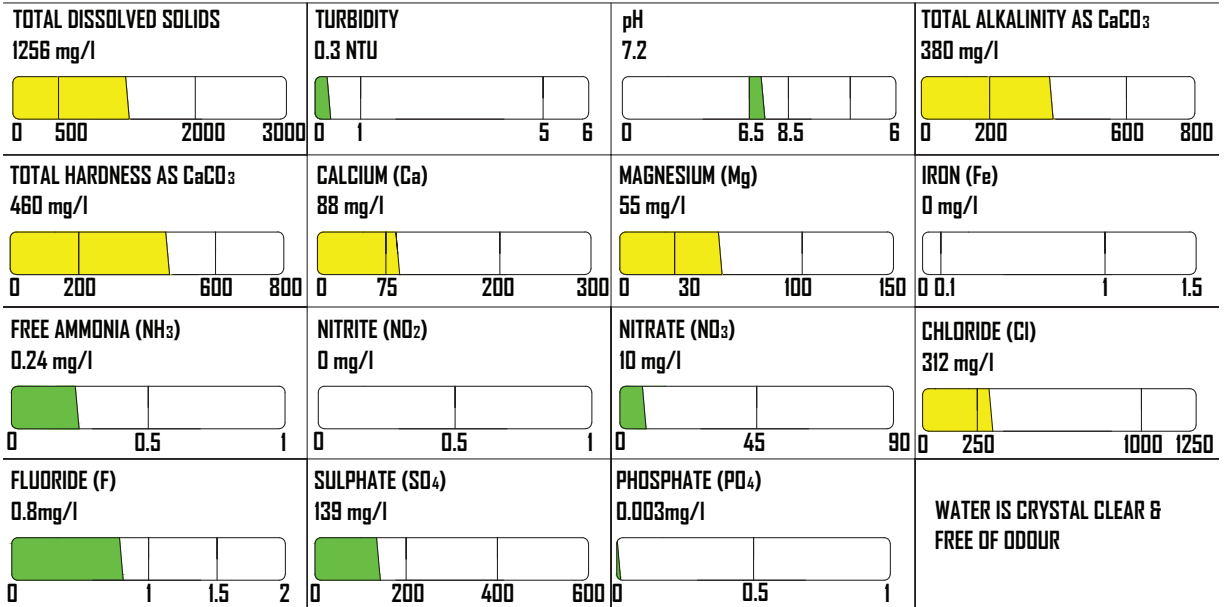
Zone 3 - Corporation Lorry Water

IT IS OBSERVED THAT WATER IS HARD BECAUSE OF THE PRESENCE OF CALCIUM AND MAGNESIUM. TOTAL DISSOLVED SOLIDS(TDS) EXCEEDS ACCEPTABLE LIMIT. IT DOES NOT HAVE DIRECT HEALTH EFFECTS BUT SOLIDS WHICH CAUSES HIGHER 'TDS' MAY BE HARMFUL TO HUMAN HEALTH. THIS WATER IS **NOT** RECOMMENDED FOR DRINKING. BUT IF THERE IS NO OTHER SOURCE OF DRINKING WATER, THEN IT SHALL BE CONSUMED.

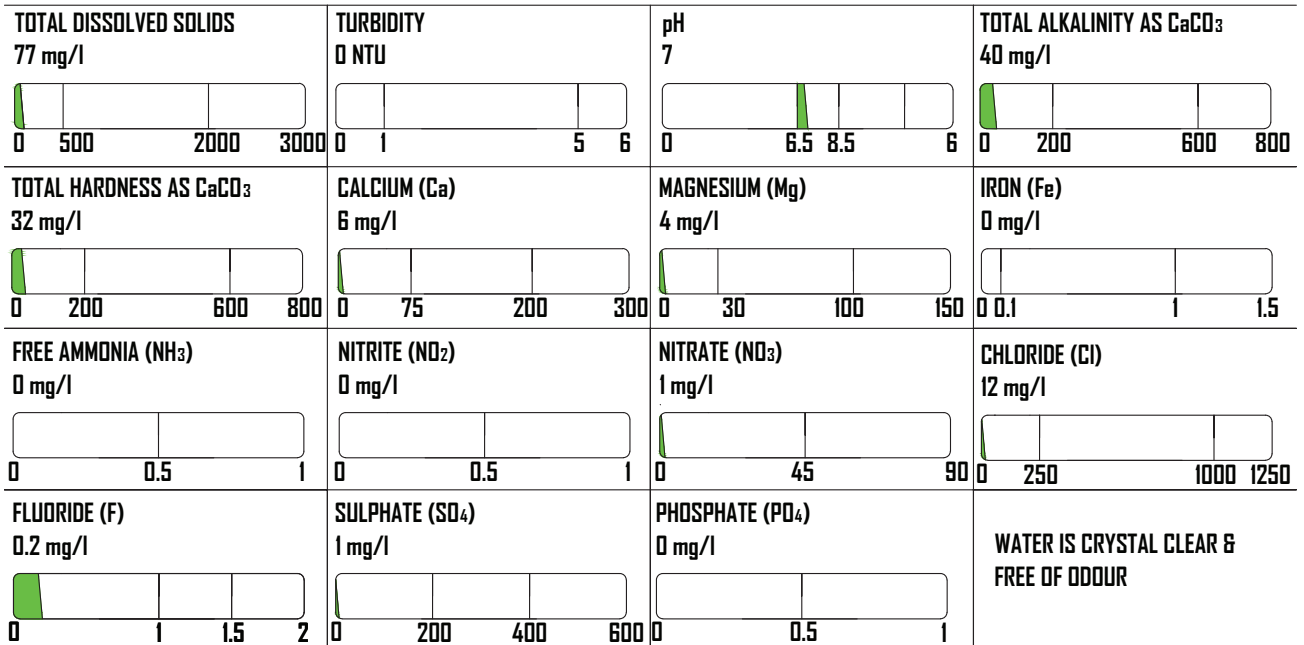
Zone 3 - Corporation Water

ALL THE DRINKING WATER PARAMETERS ARE WITHIN THE ACCEPTABLE LIMITS. THEREFORE THE WATER IS RECOMMENDED AS SAFE FOR DRINKING.

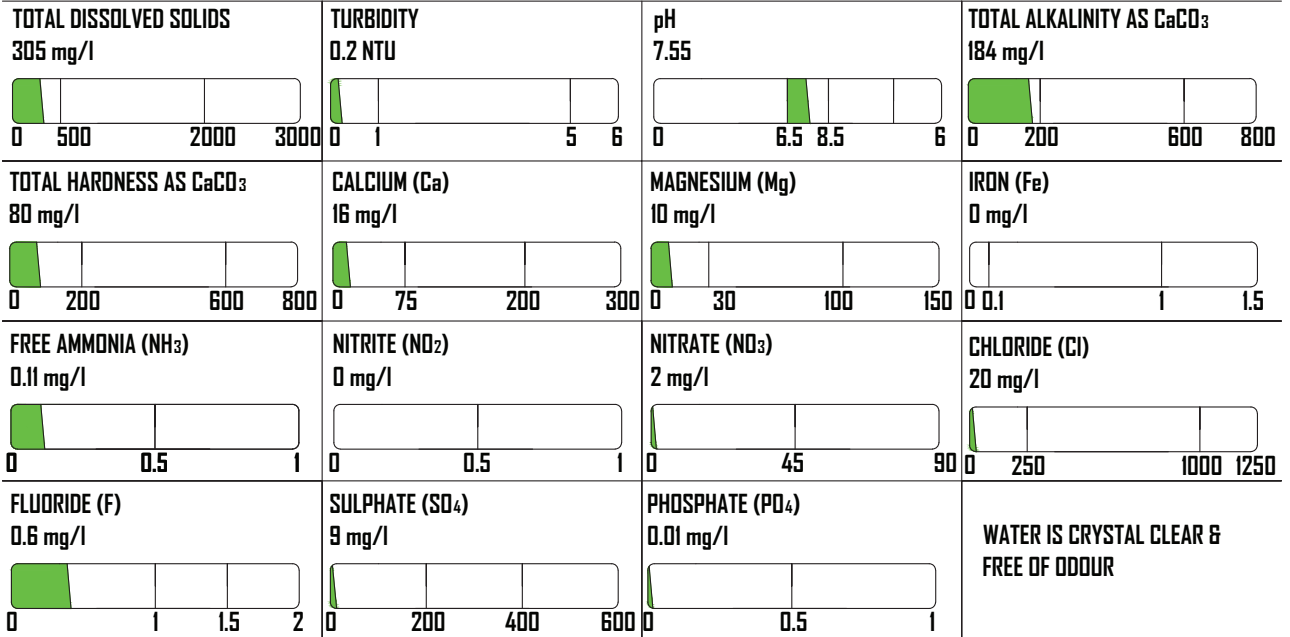
Zone 3 - Packaged Can Water

ALL THE DRINKING WATER PARAMETERS ARE WITHIN THE ACCEPTABLE LIMITS. THEREFORE THE WATER IS RECOMMENDED AS SAFE FOR DRINKING.

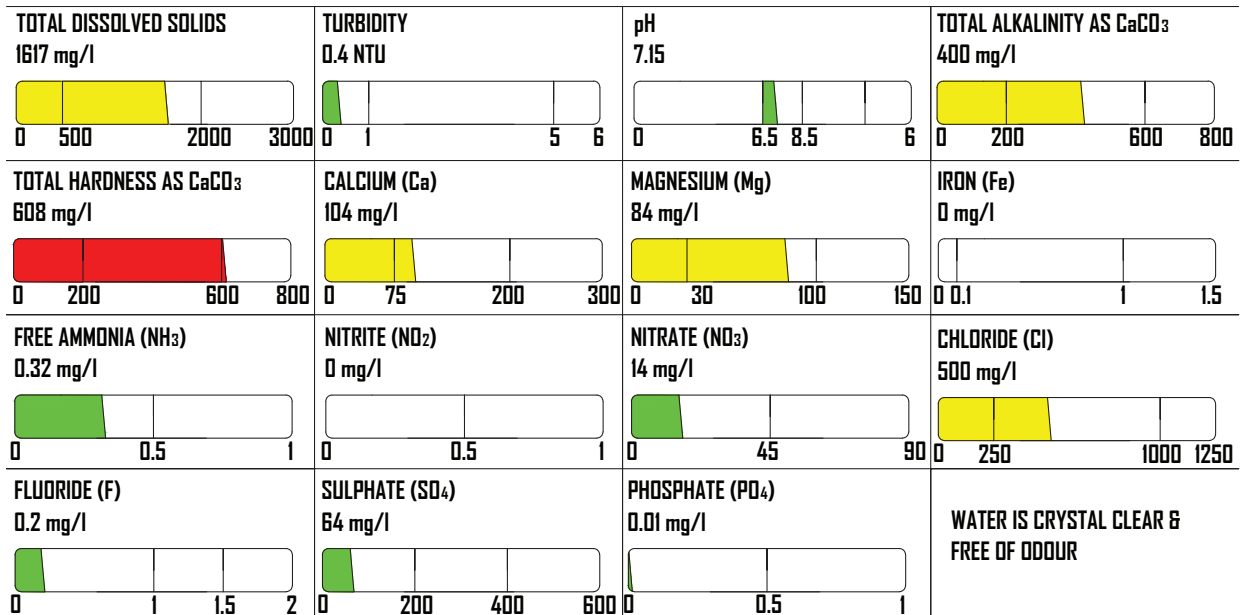
Zone 4 - Ground Water

IT IS OBSERVED THAT WATER IS HARD BECAUSE OF THE PRESENCE OF CALCIUM AND MAGNESIUM. TOTAL DISSOLVED SOLIDS(TDS) EXCEEDS PERMISSIBLE LIMIT. IT DOES NOT HAVE DIRECT HEALTH EFFECTS BUT SOLIDS WHICH CAUSES HIGHER 'TDS' MAY BE HARMFUL TO HUMAN HEALTH. THIS WATER IS **NOT** RECOMMENDED FOR DRINKING.
